SOPAC Water Resources Unit

Water Demand Management as a Tool to Mitigate Drought Impacts in Rural Water Supply Systems

REPORT OF VISIT TO KADAVU

SOPAC Miscellaneous Report 353

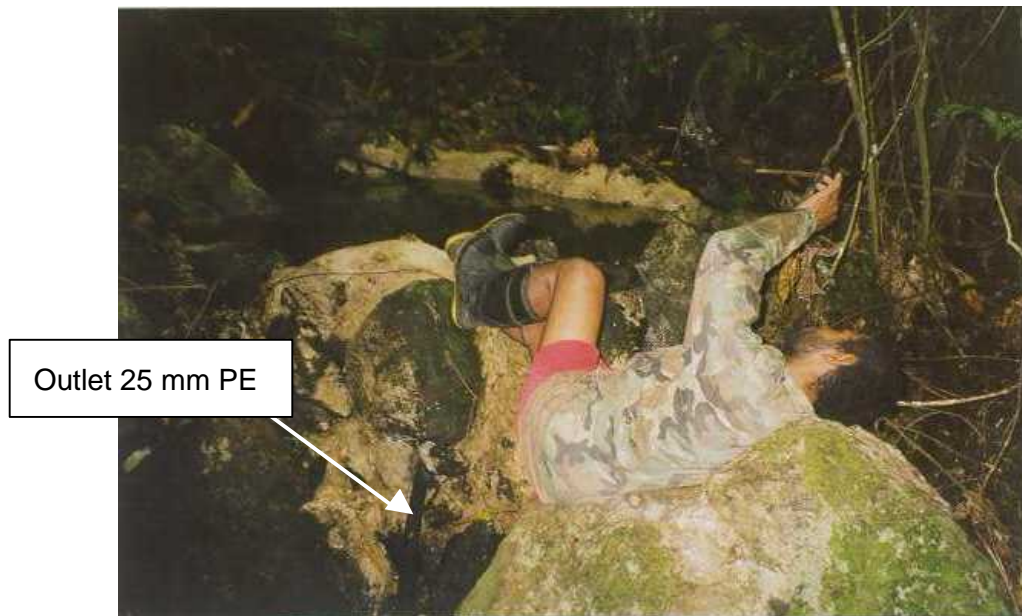
The current water supply system is fed from two springs of the same creek situated approx. 650 meter to 700 meter from the village centre at an elevation of 90 m.a.s.l. (name: **'Emergency intake'**, Figure 2) and 80 m.a.s.l.(name: **'Normal intake'**, Figure 3) . A third intake Figure 4 close by at an elevation of approx. 70 m.a.s.l. has been decommissioned by the villagers after having built the second and the third intake. Since all three intakes rely on the same catchment and creek, it seems very likely that they communicate directly resulting in a decreased flow when the respective upper intake is in use.

Both intakes currently connected are simple dams with an unprotected outlet approx. 30 to 40 cm below the maximum water surface with little protection to avoid surface contamination. The **'Normal intake'** is a moulded concrete box of 2 m x 2 m and two 12.5 mm outlet pipes without any valve while the dam at the **'Emergency intake'** is makeshift with a 25 mm pipe as outlet, again without valve or flushing possibility. Both intakes fed into a 40 PVC pipe main with makeshift connections reducing possible flow rates and pressure within the system.

Figure 2: 'Emergency Intake' with exhausted villager

Both intakes experience problems with the outlets either due to siltation in the dam, disconnection of the outlet pipe or regular clogging from leaves. The general condition they are in are poor though normal compared to other village systems.

Both outlets perform badly frequently restricting the availability of water to the village.

2. The 'Emergency Intake' should be decommissioned. Since it is the same creek that both intakes use it is unlikely that both intakes supply significantly more water than the 'Normal Intake' alone. If there is reluctance to shut down the intake it should be connected into the newly built chamber at the 'Normal intake' as shown in Figure 5.
3. To improve the water supply and enhance drought preparedness a new source should be connected to the system. During the field trip a source that according to the villagers 'never dried up' could be identified. Figure 6 shows the proposed source. Figure 7 to Figure 9 show the proposed system extension.

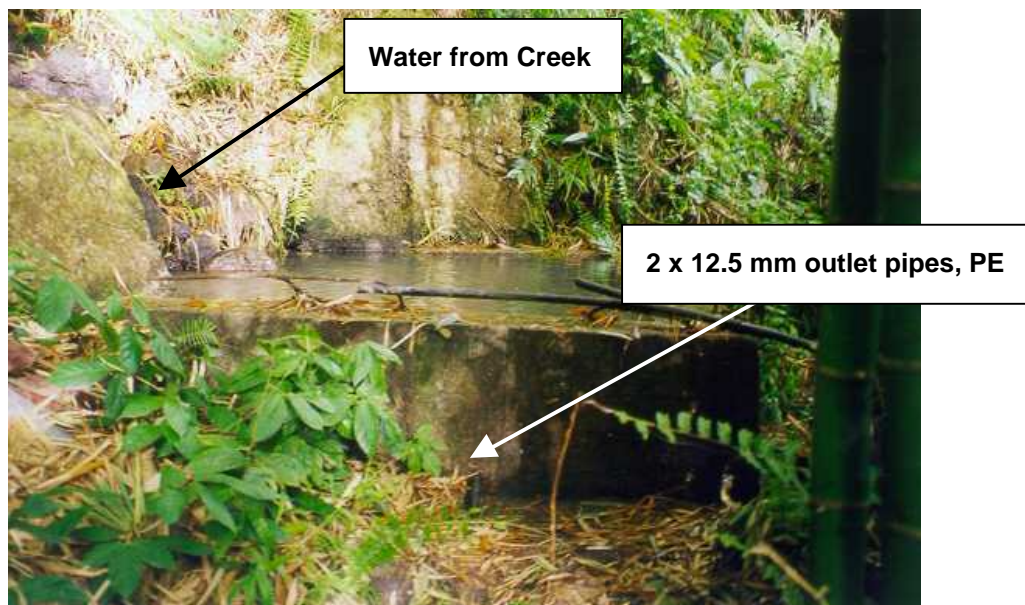
Figure 3: 'Normal Intake' built by the community

1. The outlet at the 'Normal Intake' should be replaced by a small concrete chamber out of which water will be drawn from a 40 mm PVC pipe. Figure 5 shows the proposed design.

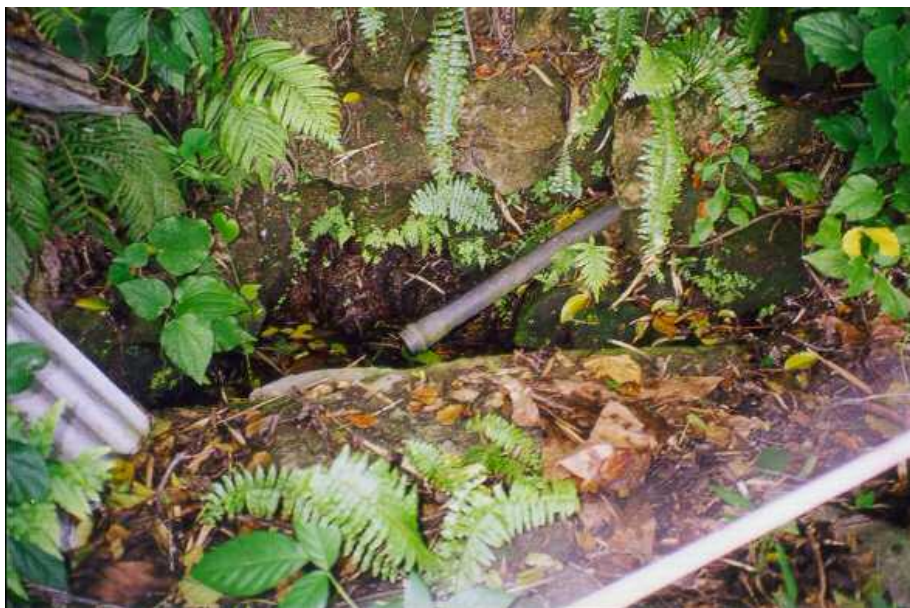
Figure 4: Decommissioned intake built by PWD

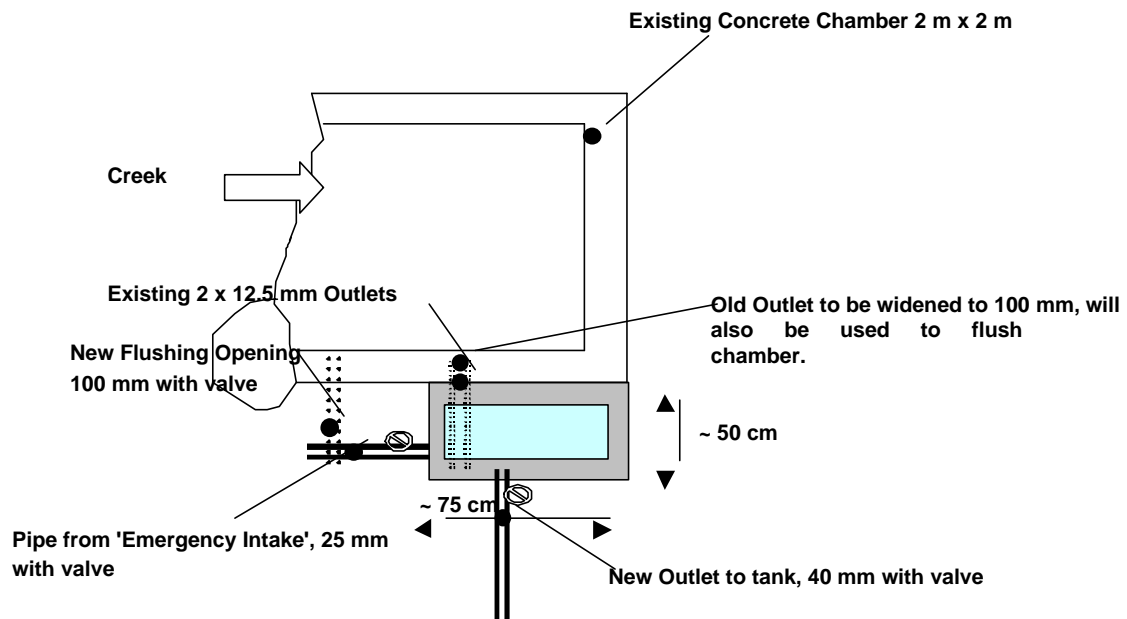
Figure 5: Suggested rehabilitation of the existing intake

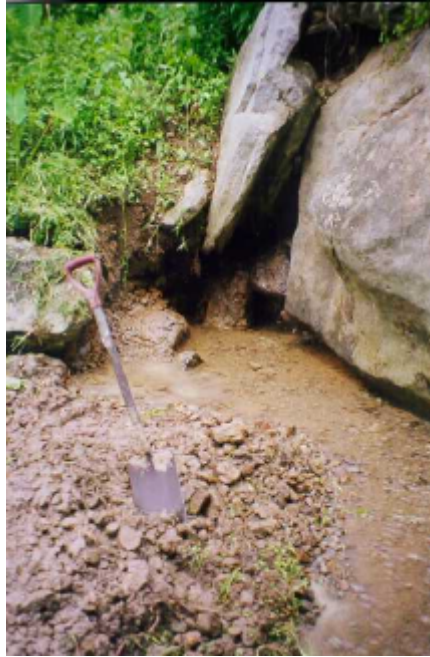
Figure 6: Proposed new spring after investigative excavations (estimated yield ~ 1.5 l/s)

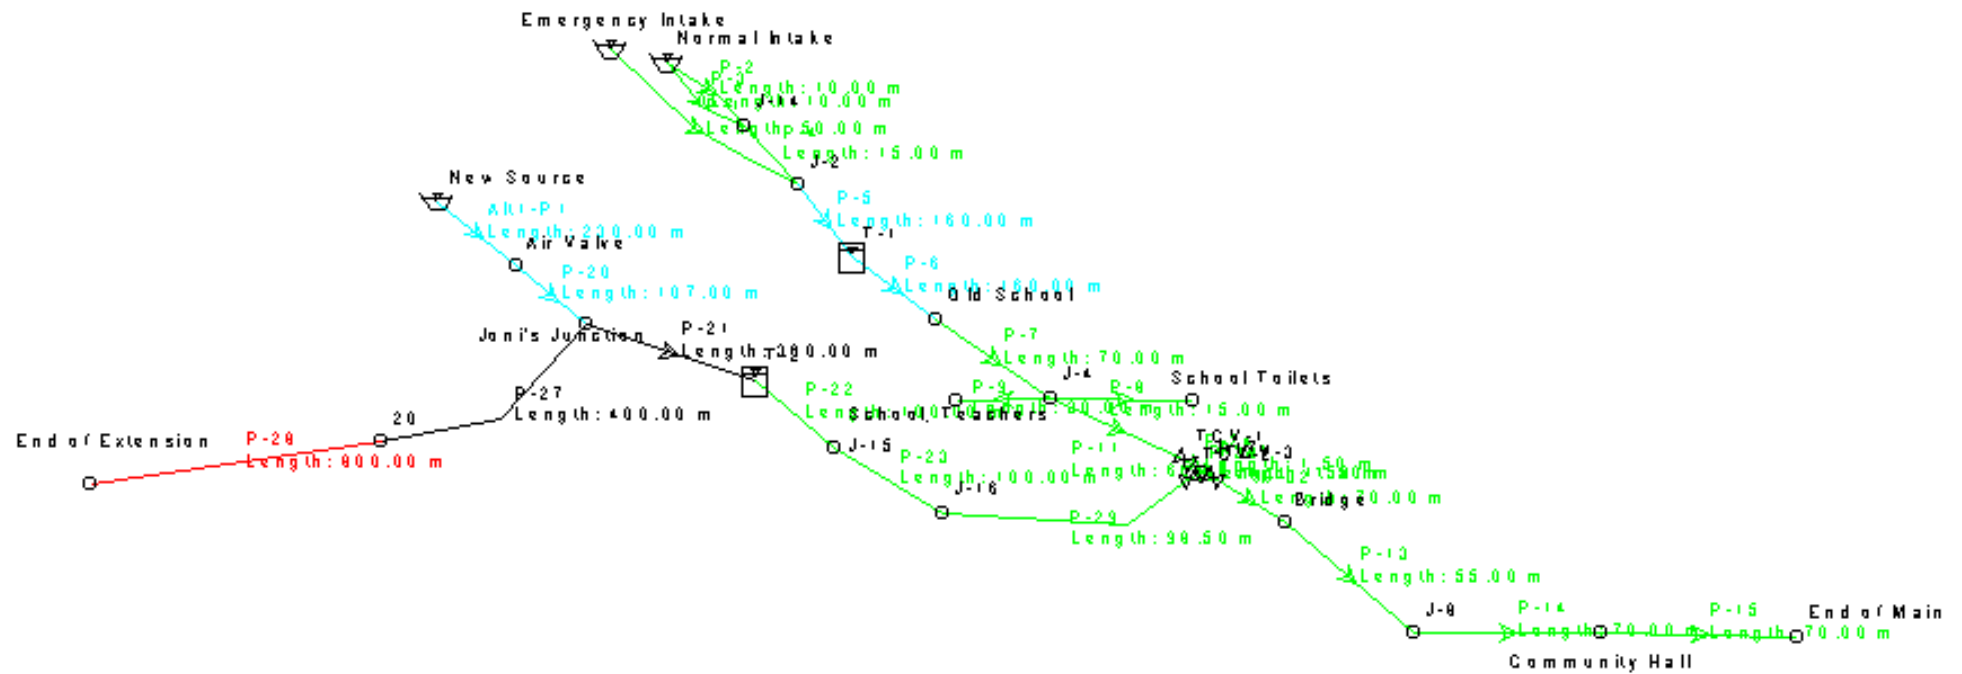
Figure 7: Proposed system extension with approximate pipe length

The extension consists of the source development, a 600 m long main (40 mm, PE pipe) and a new 50 m³ storage tank. Further 1200 m 40 mm PE pipe are necessary to supply water to the outlying settlements as shown in Figure 9. (Hydraulic analysis of the suggested extension shows that additional 1.5 l/s can be provided to the existing water supply system.

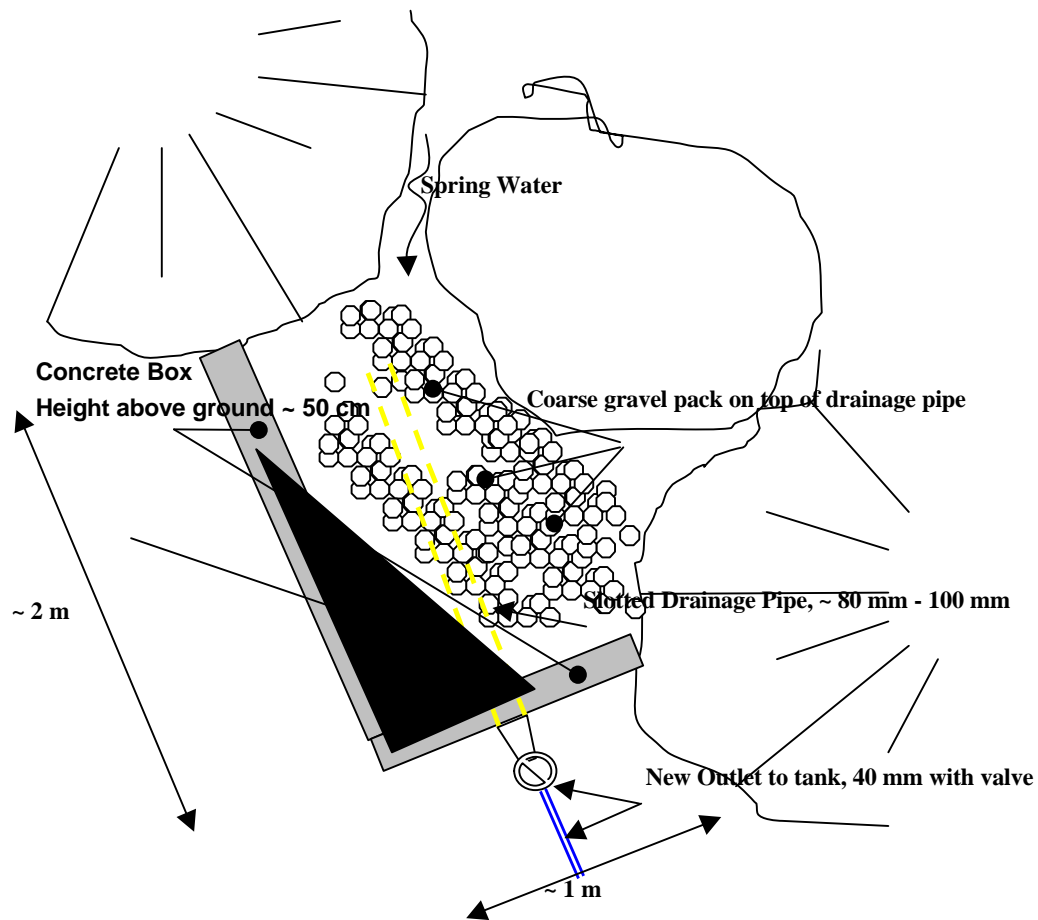
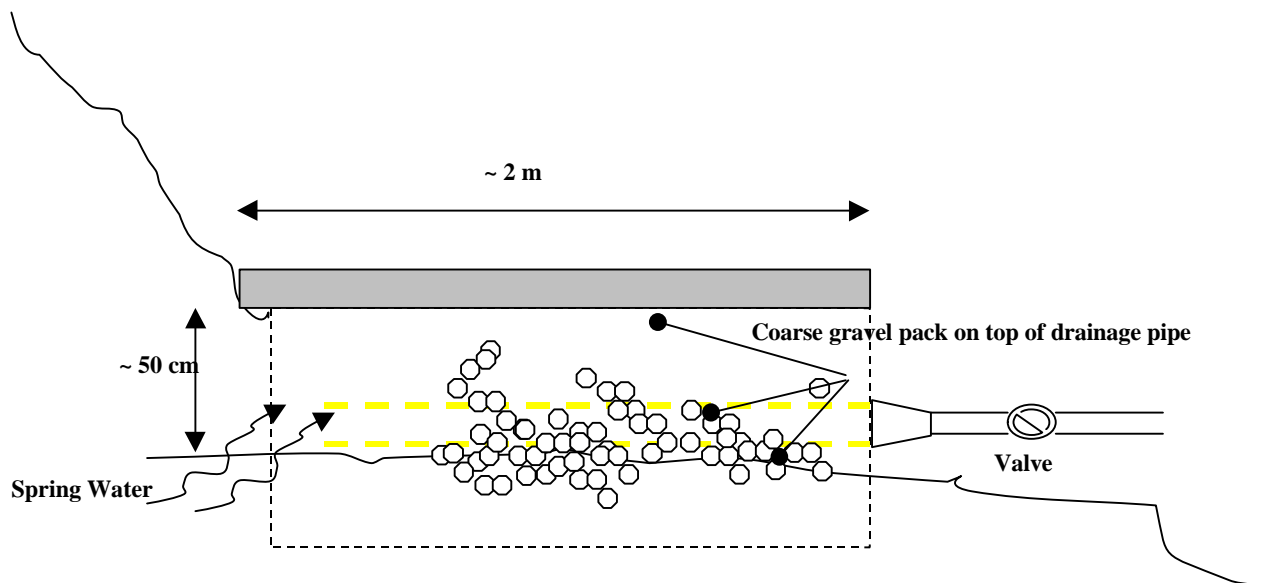
Figure 8: Plan View and Section of proposed spring development

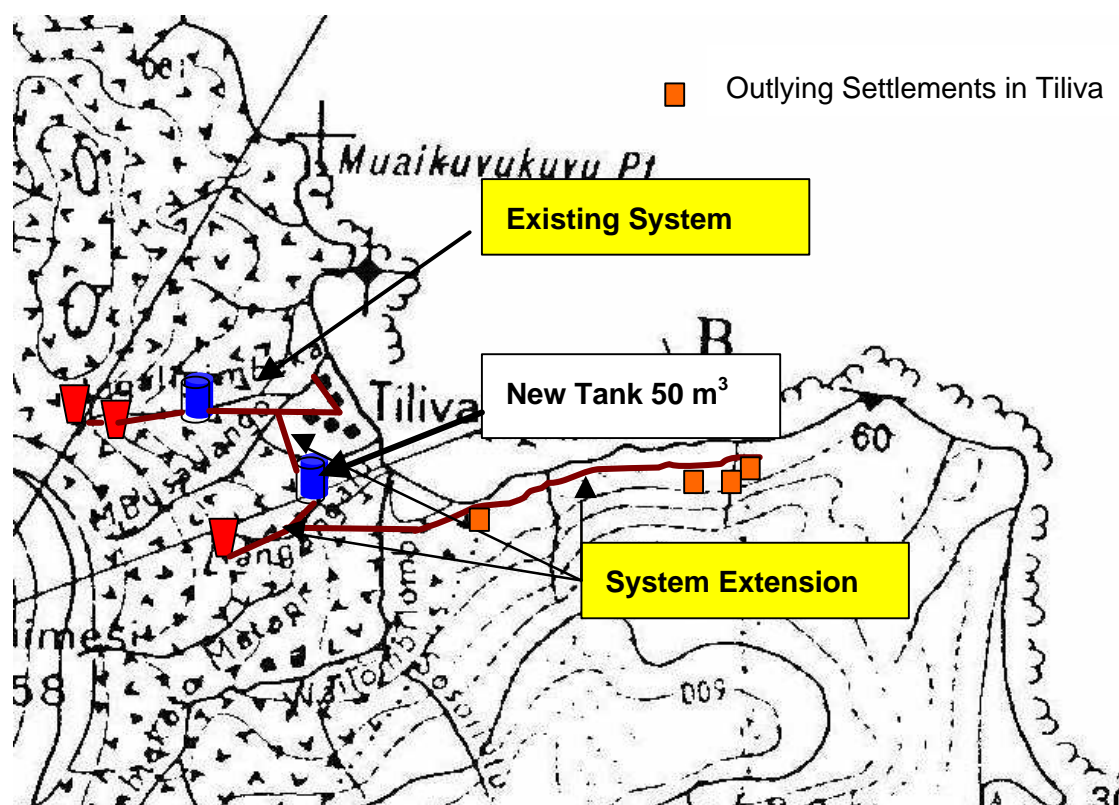
Figure 9: Schematic outline of the existing water supply system and the proposed extension

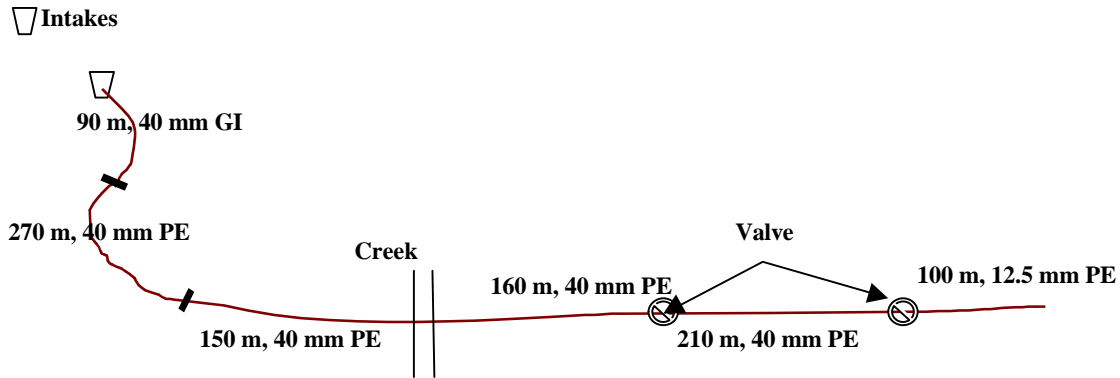
The Lagalevu water supply system provides approx. 60 people with water. It consists of two intakes about 400 m land inwards from the shoreline out of which only one, the lower one, is currently connected. Figure outlines the scheme

Figure 10: Schematic outline of the Lagalevu water supply system

In general the system does not provide water to all settlements. The problems lies in the insufficient amount of water the connected intake is able to supply and presumably particularly high head losses in the galvanised iron pipe as well as excessive (considering the amount of water available) water consumption (leakage, water wastage). Additionally the source is at an elevation of about 20 to 25 m.a.s.l. only already severely restricting possible flows (and pressure).

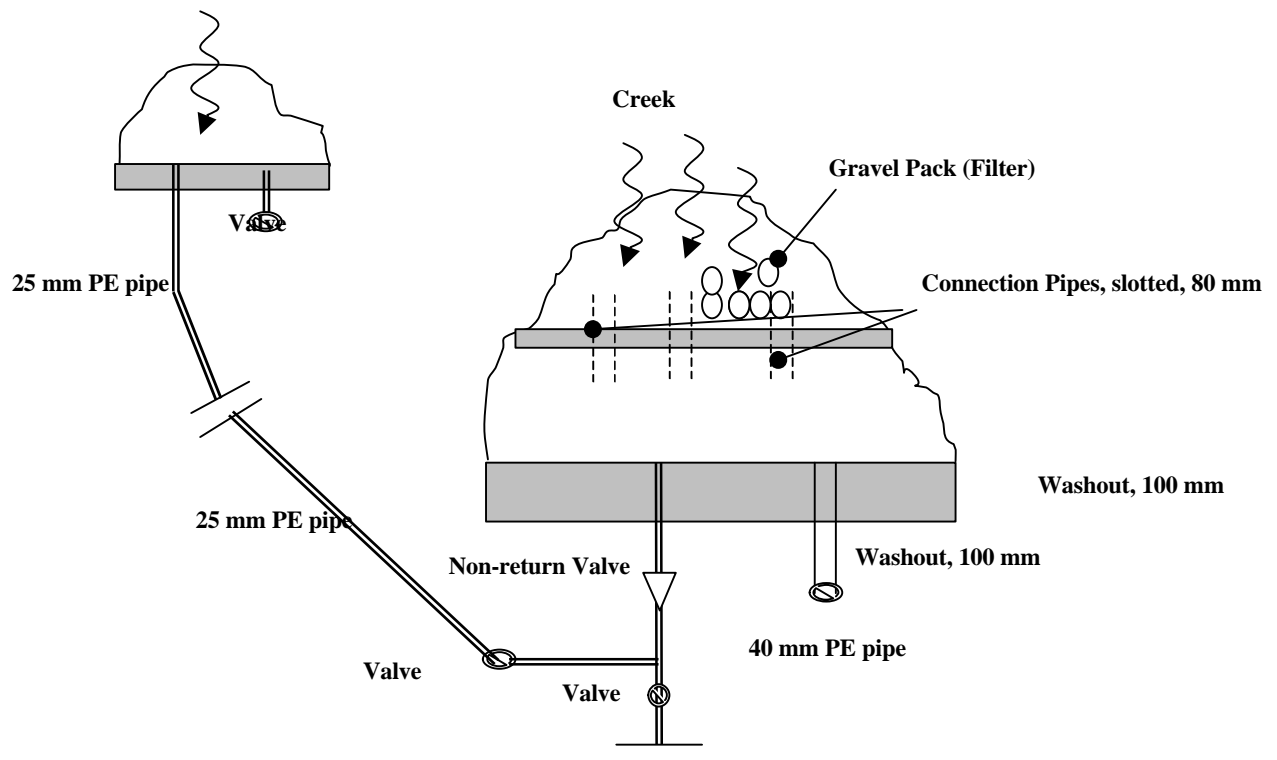
Figure 11: Proposed rehabilitation of the Lagalevu water intakes

1. The currently disconnected intake should be reconnected to the system.
2. The GI pipe needs to be replaced.

Figure 11 shows the proposed rehabilitation of the Lagalevu intake system.
