Preparation of Water Master Plan for Tarawa

KAPII Component 3, Freshwater Resources. Project 3.2.1

Report on the Protection and Management of Water Reserves, South Tarawa

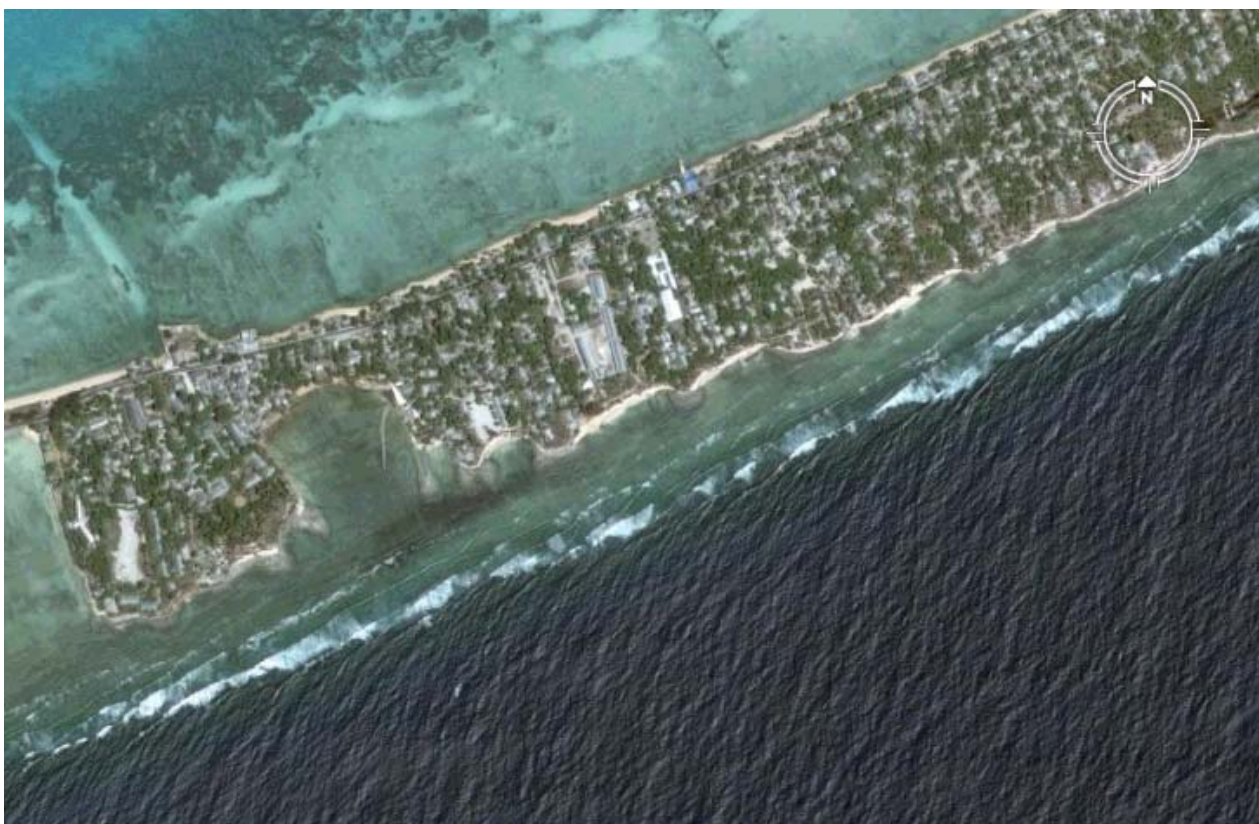
Figure 1. Teoraereke, South Tarawa. The water reserve here was abandoned due to encroached by settlers (Google Earth).

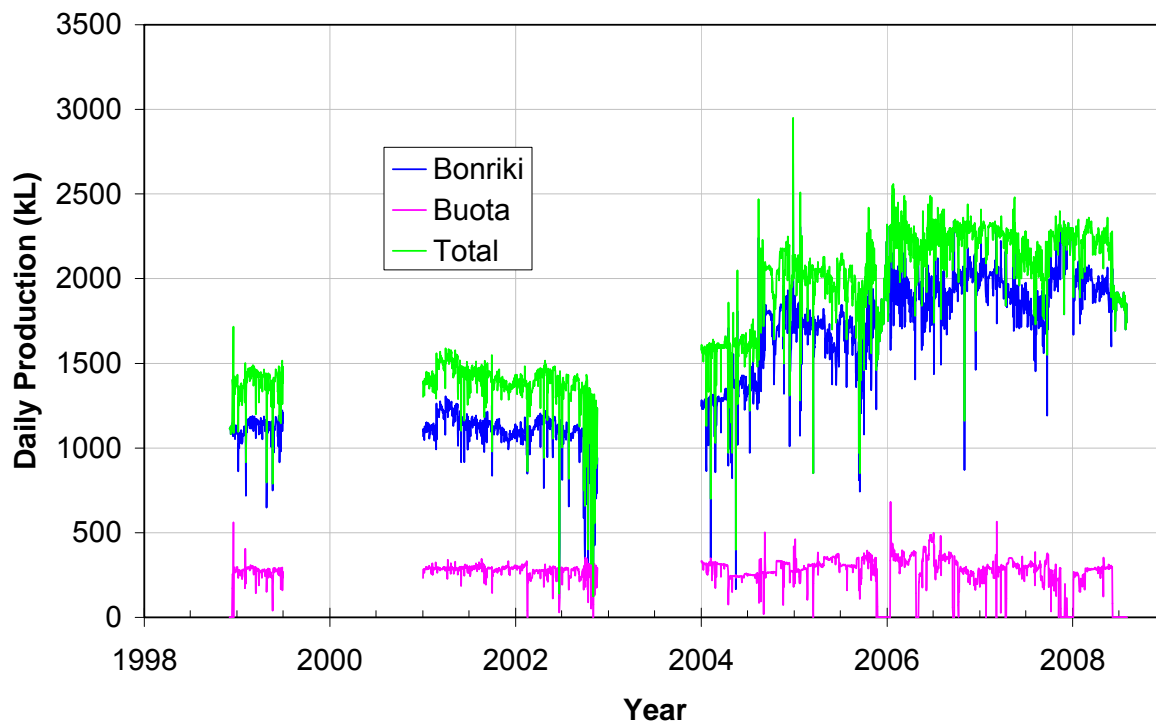
Figure 2 shows the available record of groundwater pumping from the Bonriki and Buota water reserves. It can be seen that daily data is missing during the critical drought period mid 1999 to the end of 2000 and also for late 2002 and all of 2003. Despite these gaps clear signals can be seen in the figure. There seems to have been no significant increase in pumping from Buota between late 1998 and 2008. In contrast, the flow record from Bonriki, after 2002, shows significant variations. Highly variable and decreasing flows occur in late 2002. These could have been due to the upgrading of facilities carried out during the ADB SAPHE project. After the record restarts in January 2004, a relative steady increase in extraction rate occurs until early 2006 after which the flow rate remains relatively constant.

Figure 2. Daily pumping of groundwater from the Bonriki and Buota Water Reserves and combined production for 1998 to 2008,

¹³ This is a clear indication that a backflow stop valve should be installed between Bonriki and Buota. Currently, with the pipeline between Bonriki and Buota broken, at least two pumps in Bonriki have had to be switched off to prevent backflow because of the absence of a stop valve.

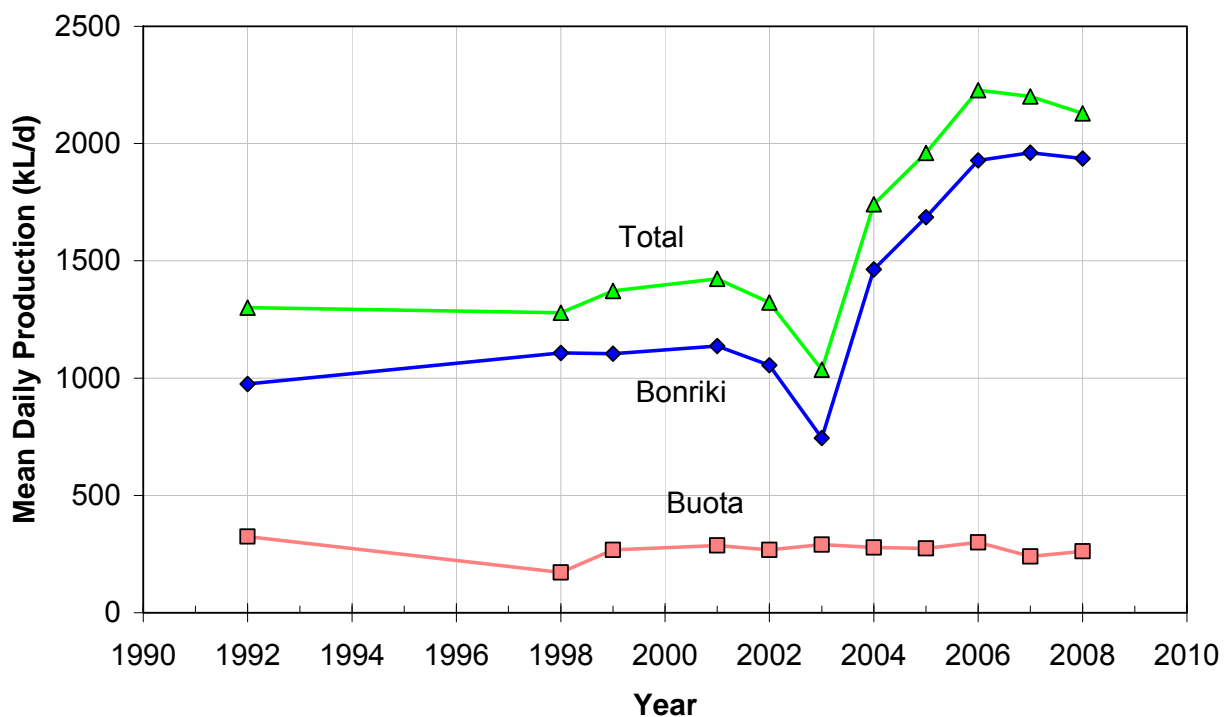
Figure 3. Mean daily groundwater pumping from Bonriki and Buota water reserves, 1992-2008.

The general features seen in the daily record in Figure 2 are apparent in the longer mean record in Figure 3. Recorded mean daily pumping of groundwater from Buota dropped between 1992 and 1998 while that at Bonriki increased by about 10%. During the 1998-2000 drought, recorded mean production at Bonriki remained relatively constant, while that at Buota increased by nearly 60% to close to the rates estimated in 1992¹⁴. In 2003, during refurbishments under the SAPHE project, there was an apparent nearly 30% decrease in annual production at Bonriki, but Buota production remained relatively constant. Indeed in the period 1999 to 2006 the production at Buota has been relatively constant with a slight decline in 2007 and 2008. The decline in total mean daily production from the combined water reserves in 2008 is partly due to the collapse of the Buota bridge and the break in the pipeline which occurred around 5 June and involved the shutdown of at least two Bonriki galleries on the Buota-Bonriki treatment station pipeline.

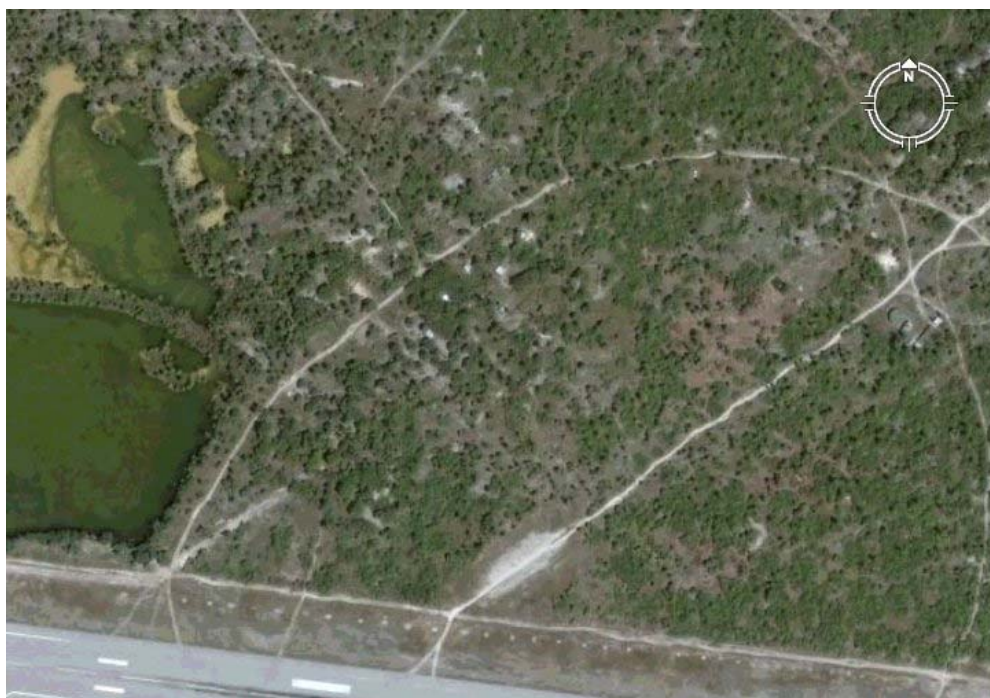
Figure 4. Salinity of pumped groundwater at Bonriki is highest near these ponds at the western end of the island (Google Earth).

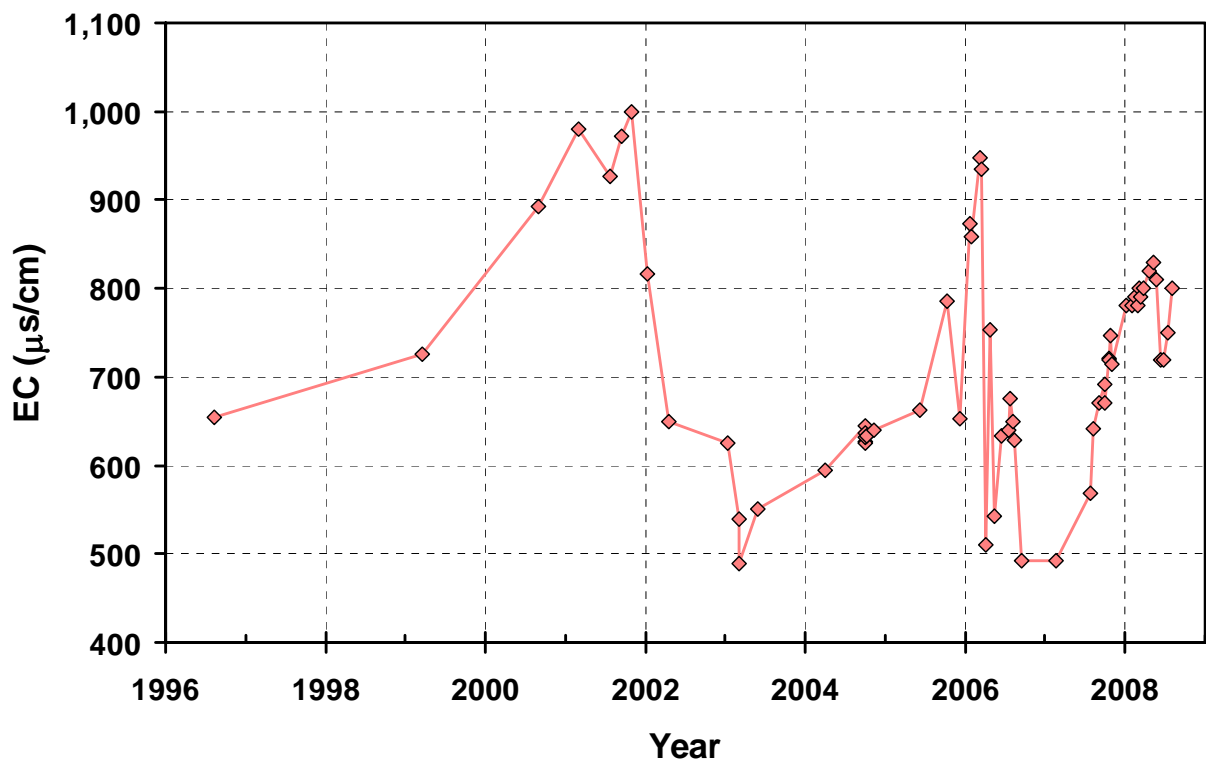
Figure 5. Electrical conductivity, EC, of the combined water pumped from Bonriki and Buota water reserves from 1996-2008.

There are several notable features about the data in Figure 5. Prior to 2001 there are few measurements of salinity, despite the fact that the worst recorded drought occurred between 1998 and 2001. After the end of the drought the EC of the combined output water continued to climb and reached a maximum in late 2001. Persistent heavy rain led to a rapid decrease to a minimum in EC in early 2003 after which salinity again generally rose to a peak in early 2006 but then declined rapidly to another minimum in late 2006 and early 2007. The onset of another ENSO-related drought in the latter half of 2007 and early 2008 again saw an increase in EC although it was nowhere near as high as that at the end of the 1998-2001 drought.

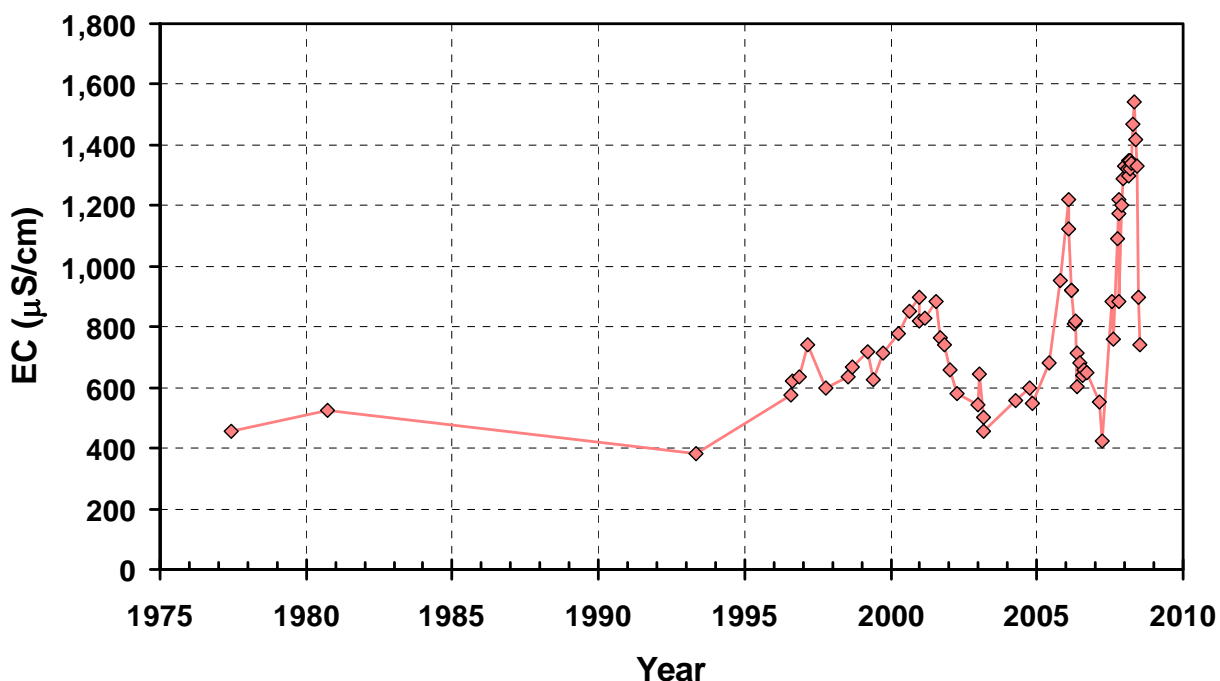
Figure 6. Salinity from an individual gallery pump station, PS 18, at Bonriki, located beside the chlorination plant for the period 1977 to 2008.

Again, there is scant data before 1996. The data does suggest that in the early pumping of the Bonriki water lens the salinity at this gallery pump station was relative low. The minimum in EC in 1993 reflects a record wet period in Tarawa. From this low, the EC systematically rose until it peaked in 2001, at the end of the severe 1998-2001 ENSO drought. The breaking of this drought

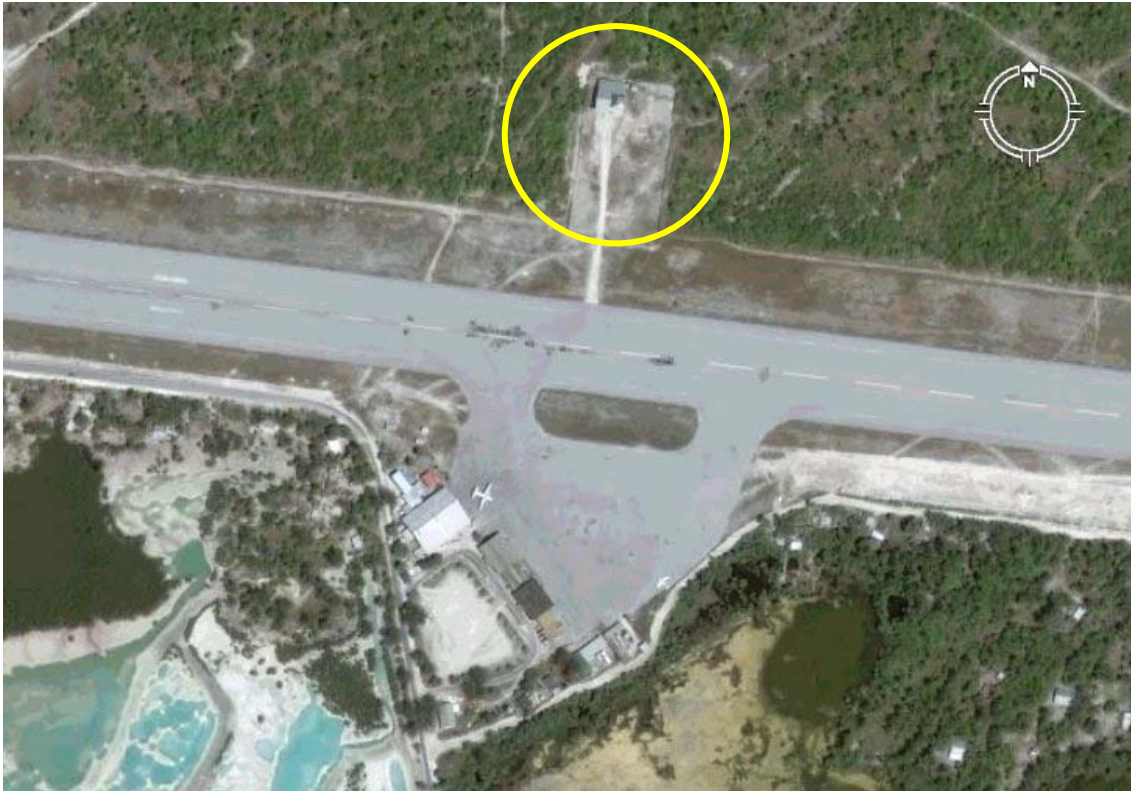
The Bonriki Airport control tower, constructed under an EU project in 2004, was cited on the northern edge of the airport runway within the Bonriki water reserve (Figure 7) because of line of site requirements and space availability. A government steering committee for the project included the lead water and environment ministries who approved the plans despite it clearly contravening the water reserve regulations and public health bye-laws. To make matters even worse, the septic tank toilet for the control tower is located directly over one of the two infiltration gallery arms leading to Bonriki pump station, PS 7 as shown in Figure 8.

Figure 7. The Bonriki International Airport Control Tower (circled) located on the water reserve (Google Earth)

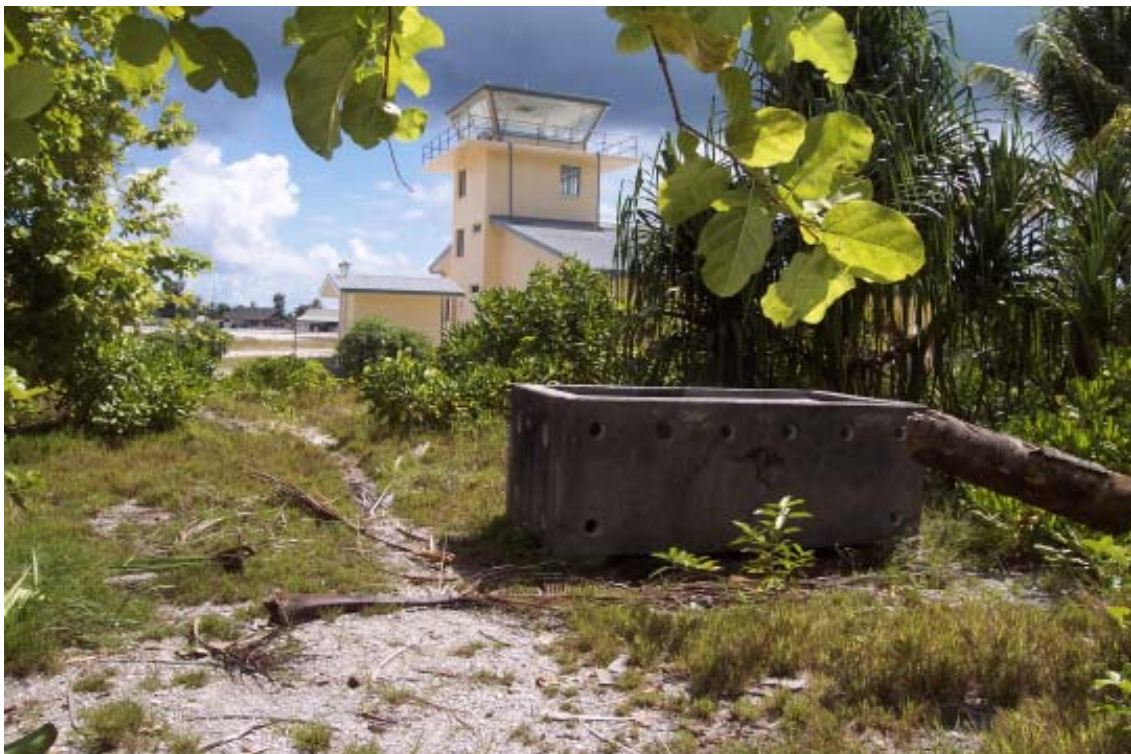
Figure 8. The septic tank toilet for the Control Tower is located over one of the infiltration gallery arms leading to Bonriki pump station 7 in the foreground right

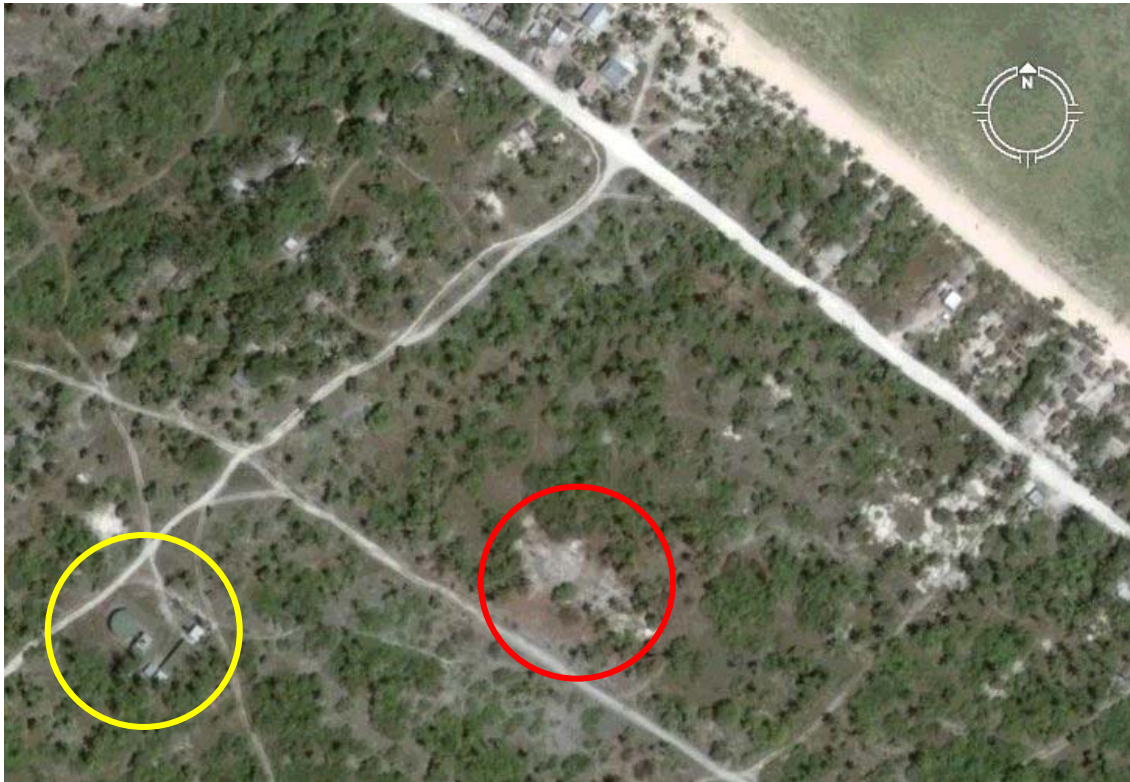
Figure 9. Encroachment of houses onto the Bonriki water reserve across the 50 m boundary road in the northeast. The Bonriki water treatment and pumping plant near the centre of the reserve is circled in yellow and an active cemetery is circled in red (Google Earth).

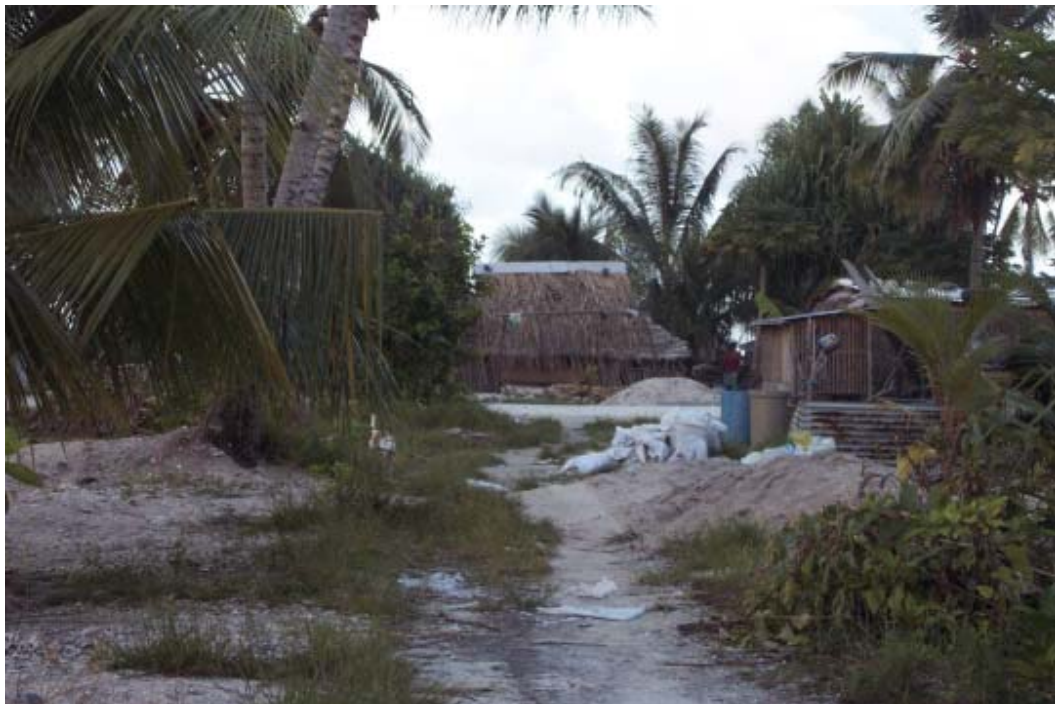
Figure 10. A typical house erected illegally on the Bonriki water reserve.

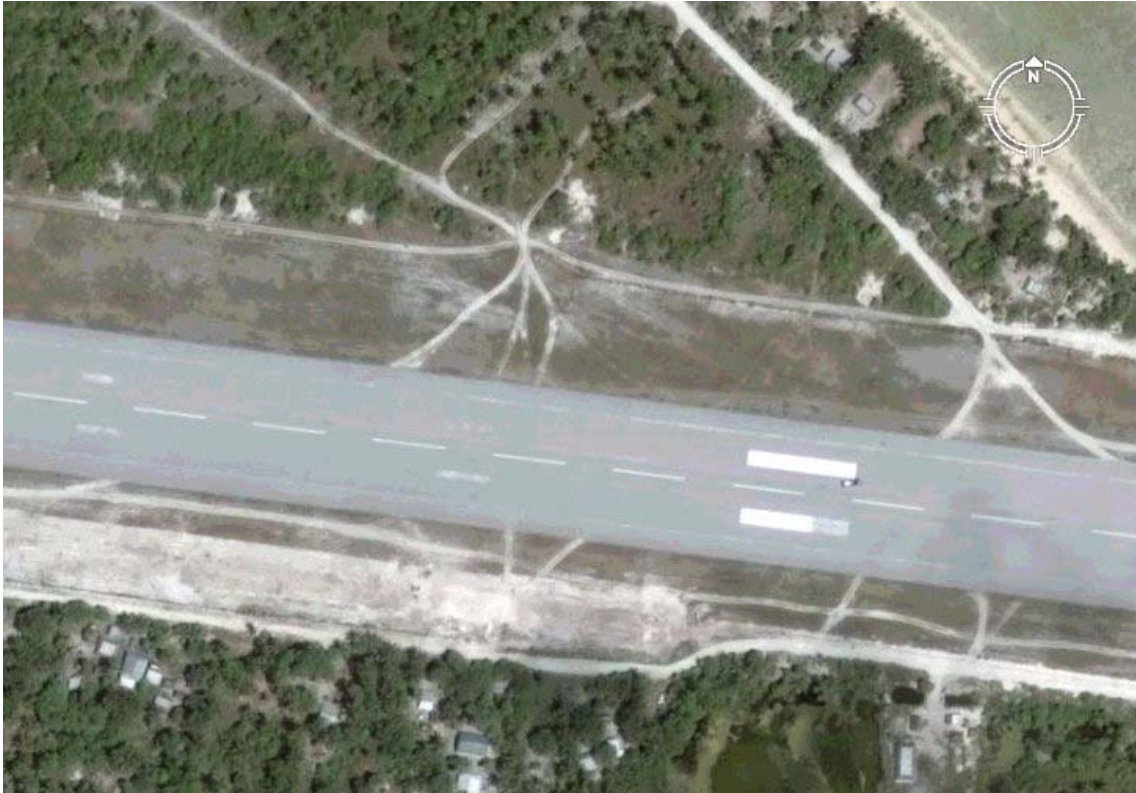
Figure 11. Sand and gravel mining within the Bonriki water reserve and close to gallery pump station PS1. The boundary road is again on the northeast ocean side (Google Earth).

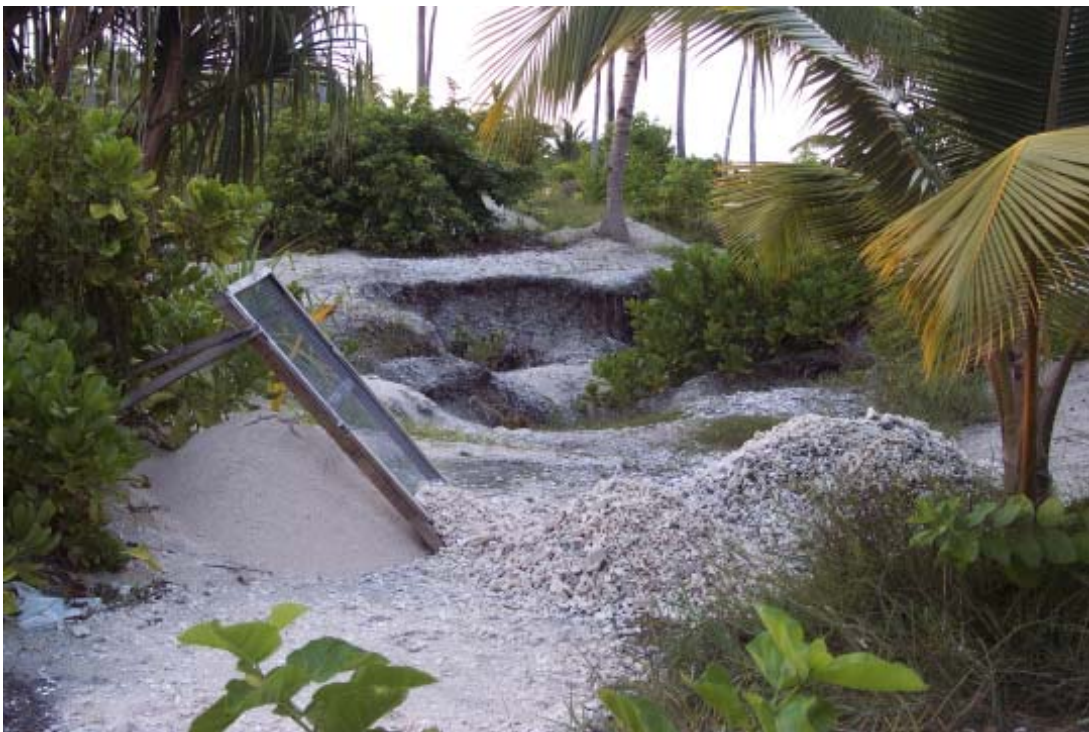
Figure 12. Sand and gravel mining on the Bonriki reserve. Note the undercutting of coconut trees which eventually leads to death of the tree.

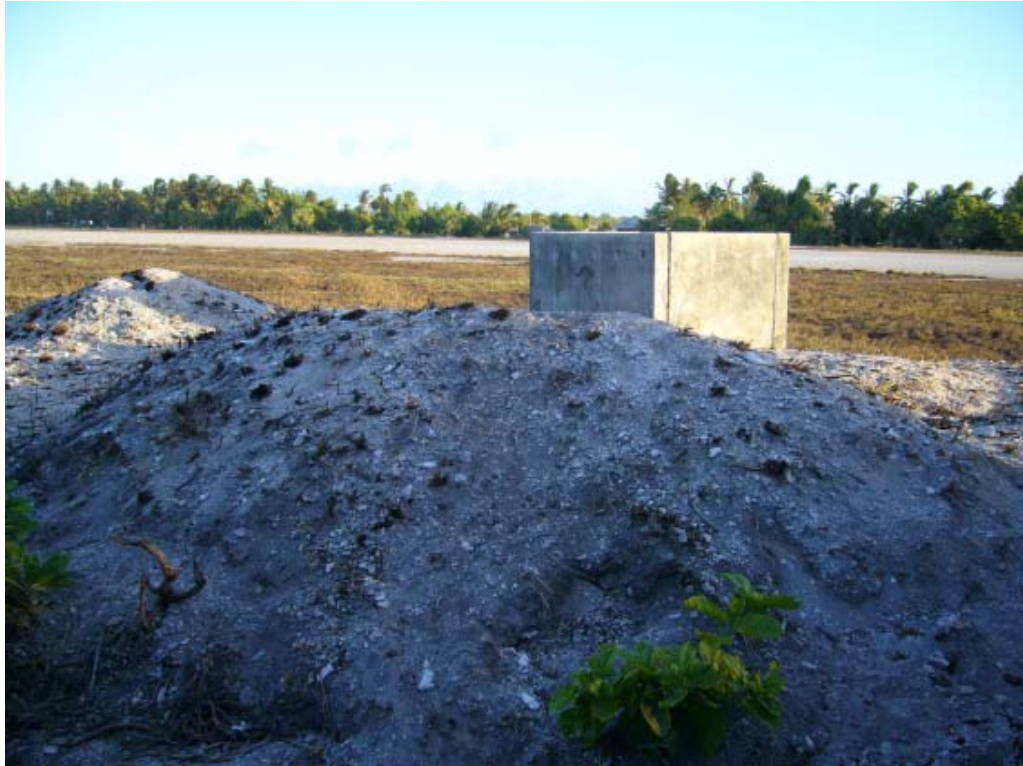
Figure 13. Gravel mining beside Bonriki gallery pumping station PS1 on the eastern end of the reserve.

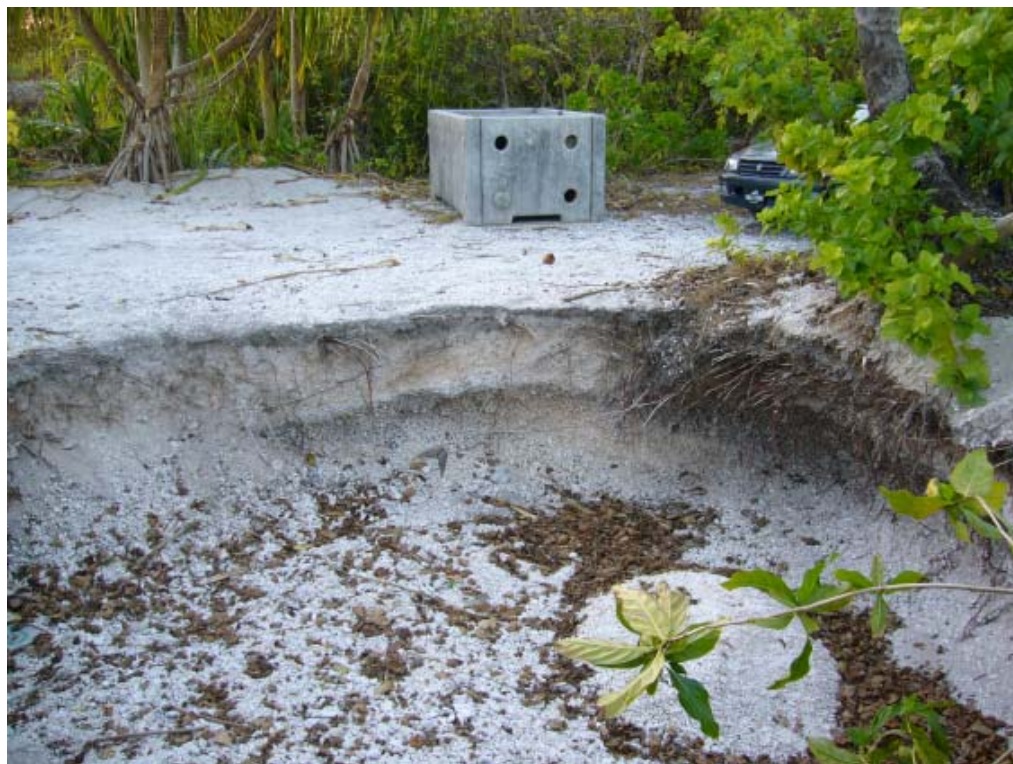
Figure 14. Sand and gravel mining has completely destroyed salinity monitoring borehole BN 16 (beside PS 7), one of the oldest and the deepest borehole in Bonriki.

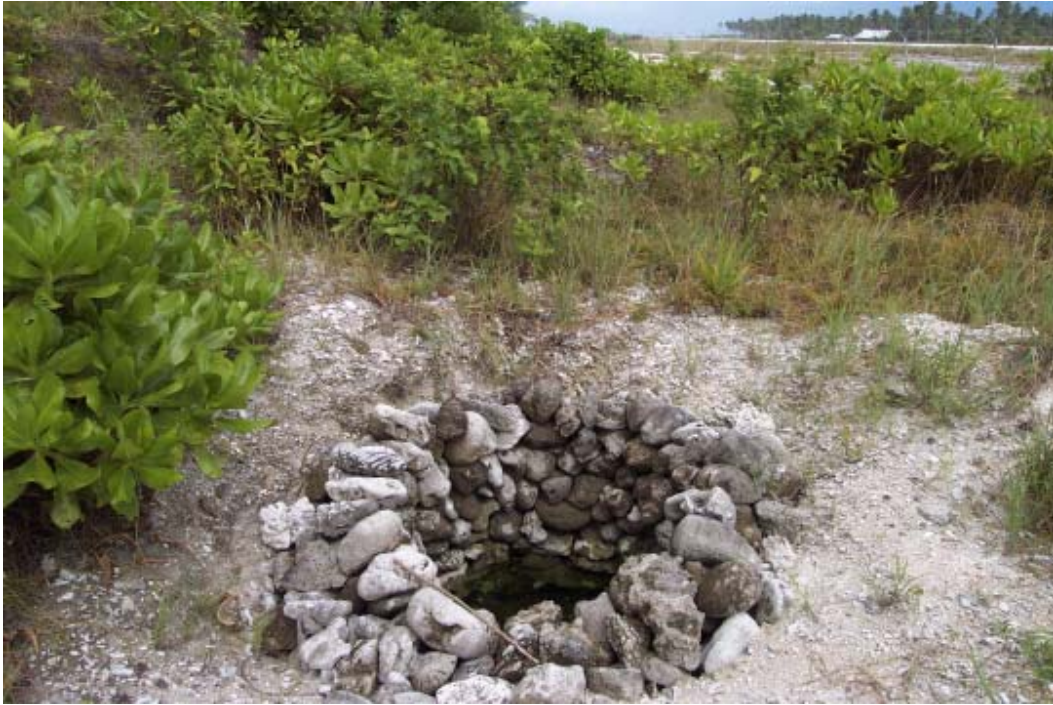
Figure 15. Open well dug down to the groundwater near PS 1. This has algal blooms growing on the water surface.

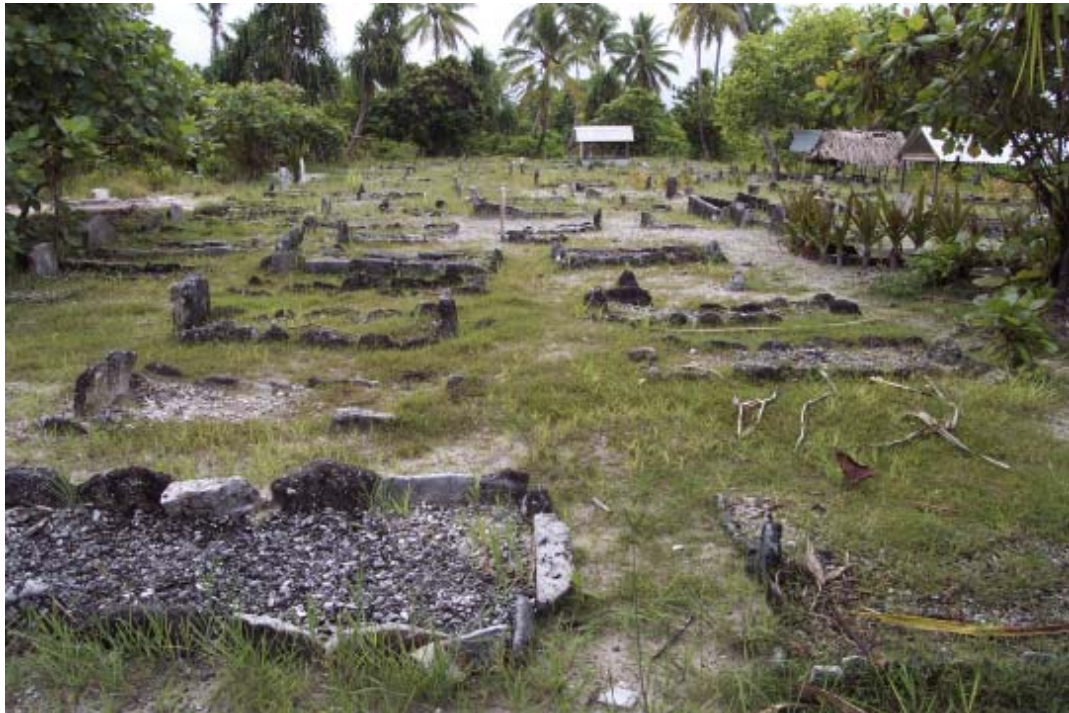
Figure 16. Active graveyard on the Bonriki water reserve close to the centre of the reserve and between PS 6 and PS 8.

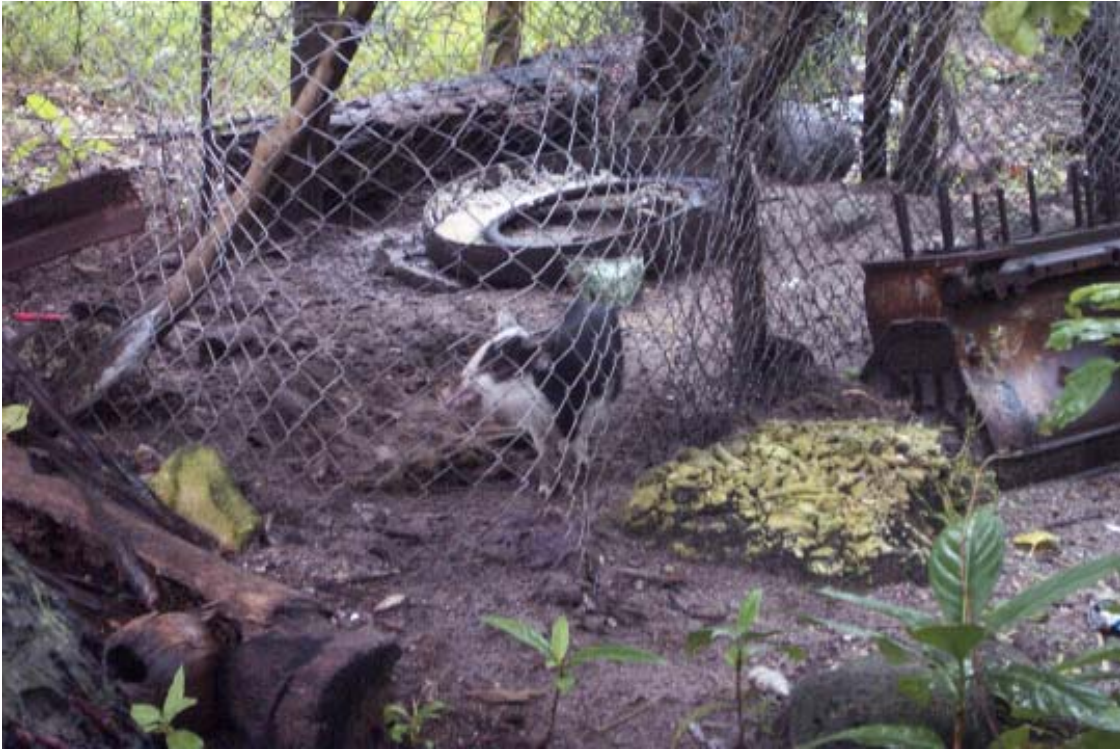
Figure 17. Raising of pigs on the Bonriki water reserve between PS 14 and PS 15.

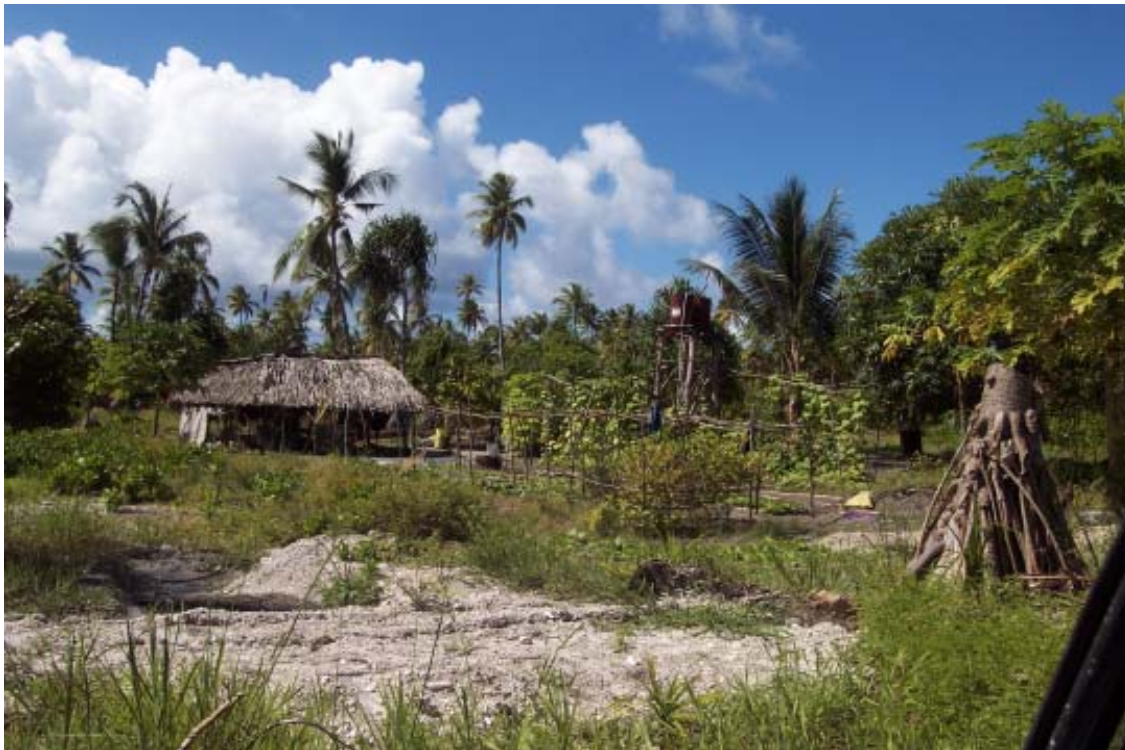
Figure 18. Growing vegetable crops on the Bonriki water reserve near PS 13.

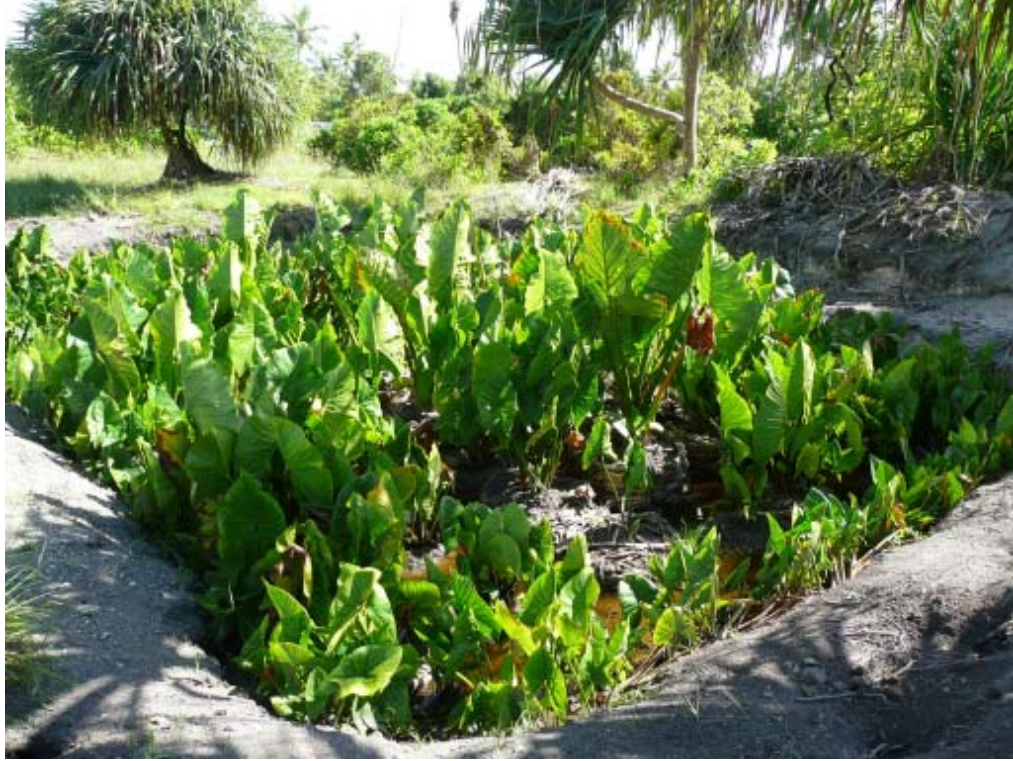
Figure 19. Babwai (swamp taro) growing on the western side of the Bonriki water reserve. It is grown and fertilised directly in the groundwater.

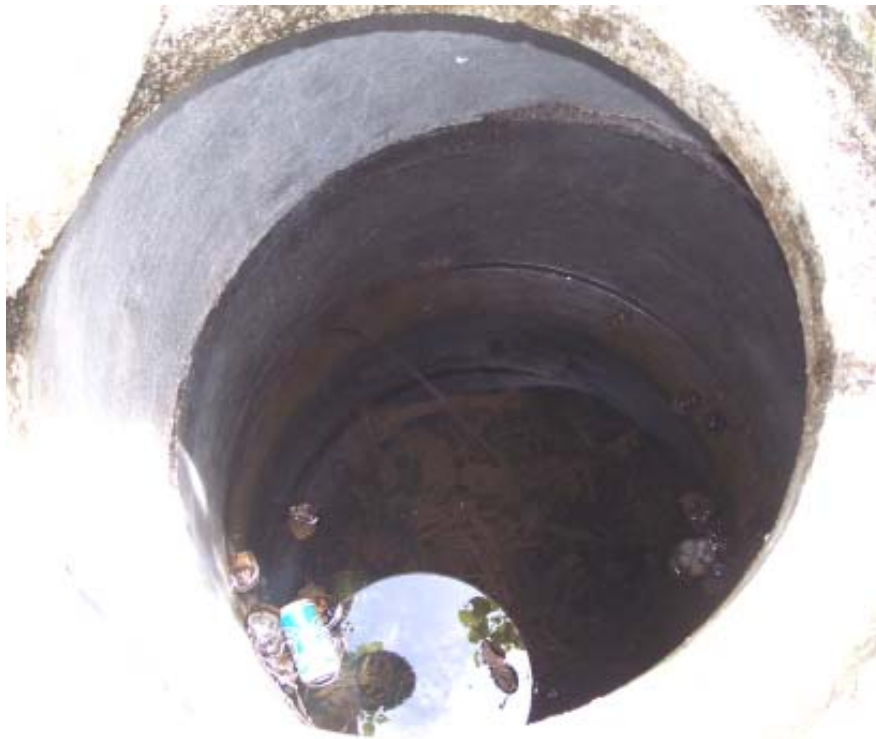
- Direct pollution (Figure 20). The terminal wells of gallery pump stations can be opened and these have been used as rubbish dumps and as toilets. The risk to Tarawa’s water supply from this is immense.

Figure 20. Rubbish thrown down the terminal well of PS 7.

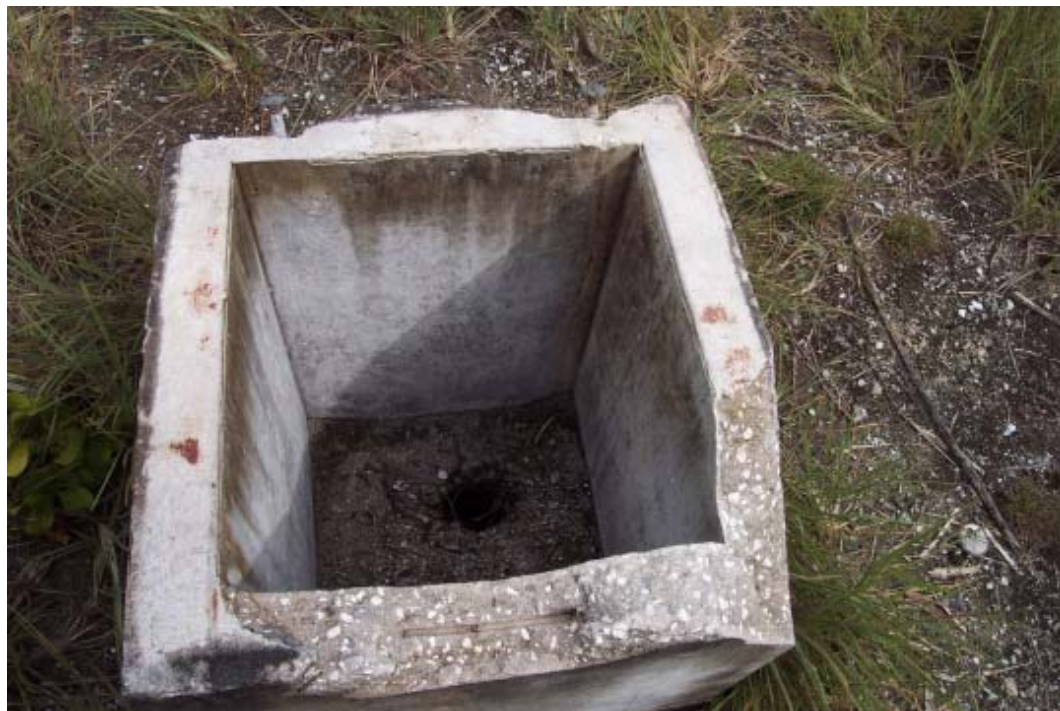
- Vandalism of infrastructure (Figure 21). Vandalism is a continuing problem in the water reserves. Pumps have been burnt and salinity monitoring boreholes, essential for tracking the impacts of pumping are regularly destroyed. This points to significant problems in the management of the water reserves.

Figure 21. Vandalism to infrastructure is a reoccurring problem in water reserves. This was Bonriki salinity monitoring borehole BN4B. The steel lid has been smashed off and the piezometer tube and salinity monitoring tubes have all been removed.

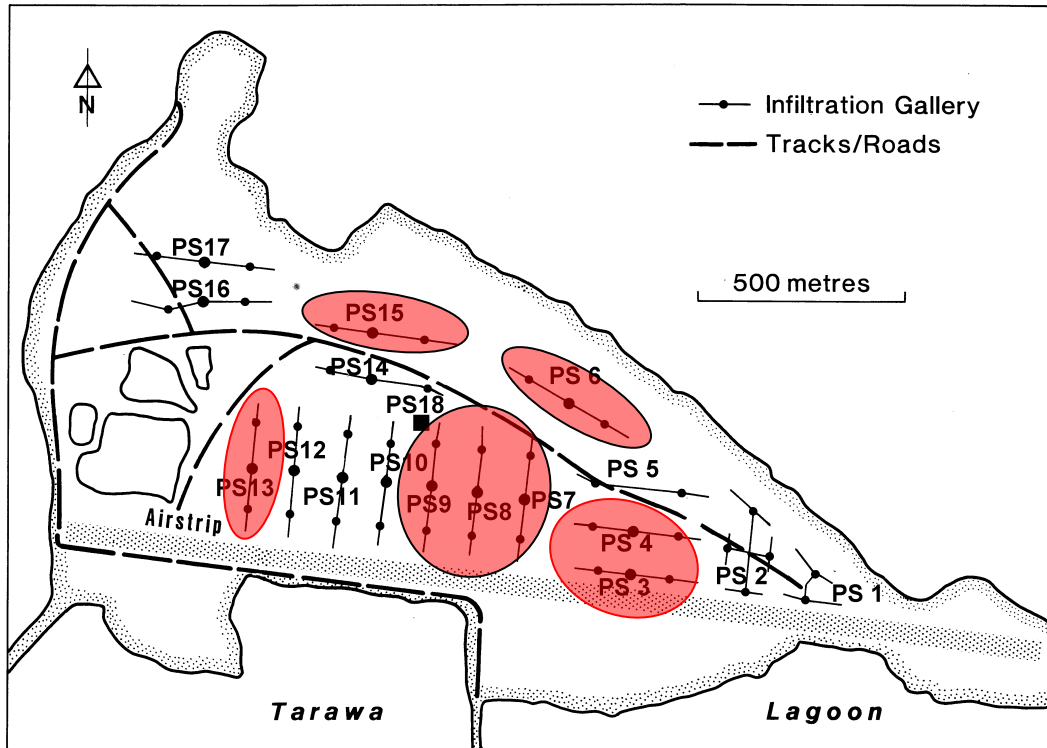
Figure 22. Distribution of positive *E. Coli* water samples from pumping galleries on Bonriki

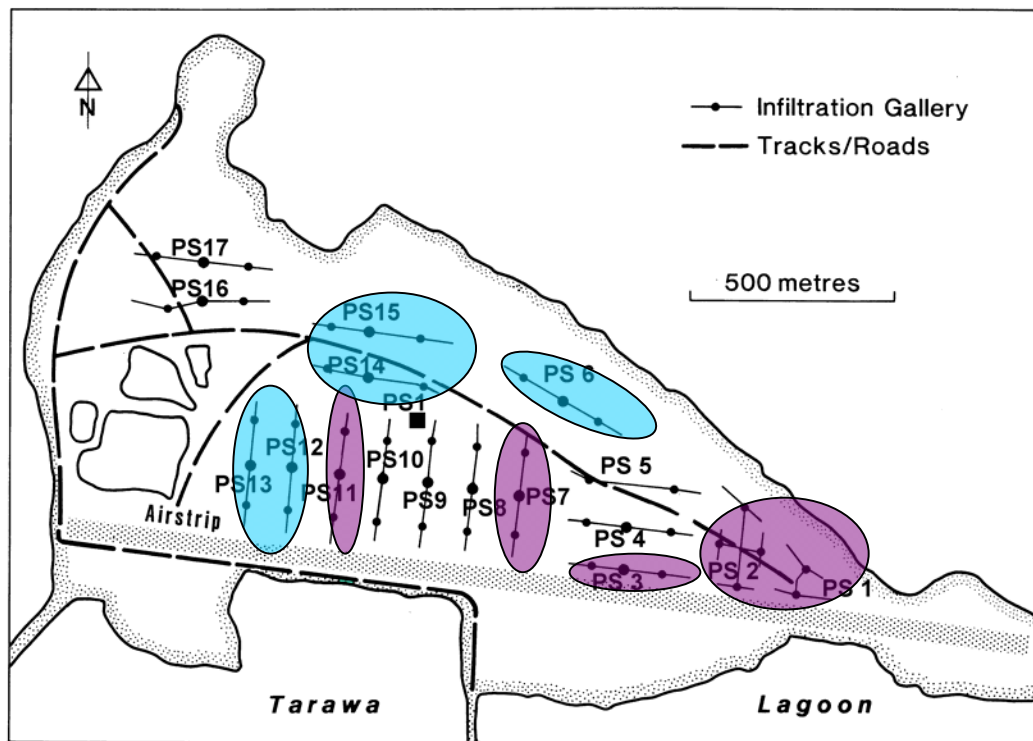
Another way of examining potential pollution of groundwater is to determine the ratio of dissolved organic carbon, DOC, to total dissolved nitrogen. When the value of the molar ratio is close to 2.9 (the Redfield ratio), this indicates the presence of micro-organisms or algae. When it is significantly less than 2.9 it indicates pollution by other sources of inorganic nitrogen. Figure 23 shows the distribution for both in Bonriki, in October 2004, indicating significant pollution of the groundwater.

Figure 23. Pumping galleries on Bonriki with DOC/TDN ratios close to the Redfield ratio for micro-organisms (blue coloured) and significantly lower than (< 2.9) the Redfield ratio suggesting inorganic sources of TDN (purple coloured).
