# **REVIEW OF THE ROTUMA WATER SUPPLY AND DISTRIBUTION SYSTEM FIJI ISLANDS**

Paula Dawe  
*SOPAC Water Resources Unit*

*February 2001*

*SOPAC Preliminary Report 131*

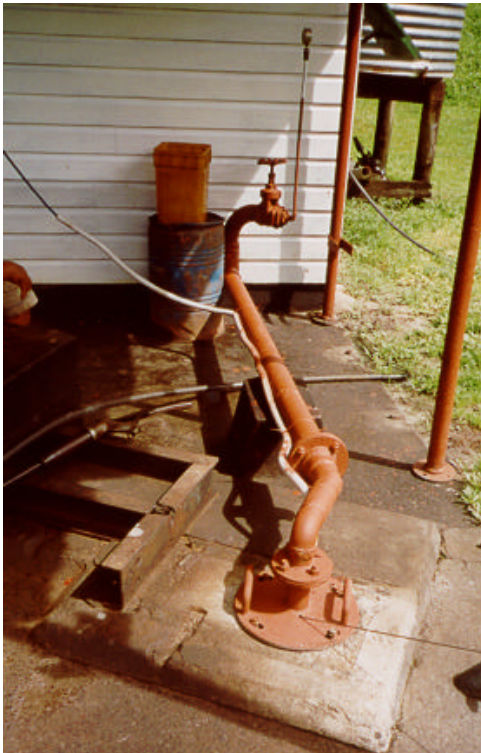
**Picture 1:** Motusa borehole. Bore pipe leading into the pump house is painted red to protect it from the sun.

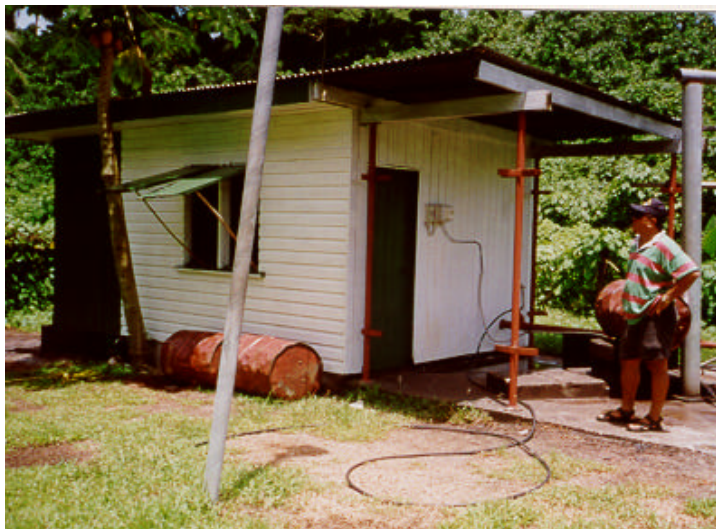
**Picture 2:** The Lepjea pump house recently constructed to house the new diesel-run pumps installed in 1999.

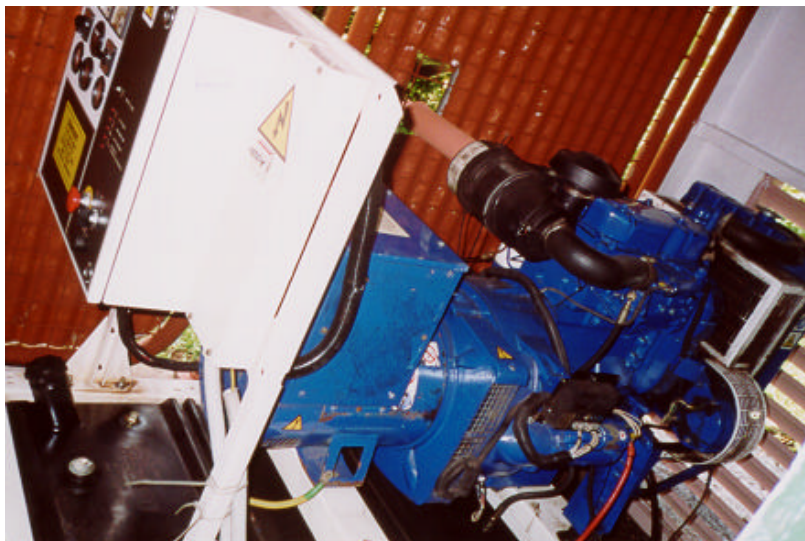
**Picture 3:** The Lepjea diesel powered bore pump and control panel. The pump was installed in late 1999. The control panel is manually operated by the site Warden. The pump will automatically shut down when there is over 4 ft (1.2 m) of drawdown in the groundwater level.

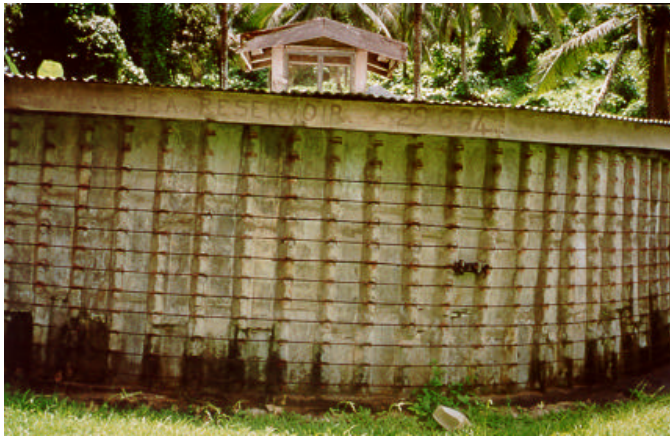
The tank in Lepjea is a circular reinforced-concrete 40 000-gallon (181.84 m<sup>3</sup>) tank. A corrugated iron roof with obvious rust spots covers the tank. The gap between the roof and the tank wall is covered by mesh that is both torn and dirty.

**Picture 4:** The Lepjea tank, built in 1984 as can be seen by the inscription on the roof beam. The brown stains on the bottom indicate leakage from the tank. The slight slant of the roof to prevent pooling of water on the roof is not apparent from this angle.

- All three storage tanks in Rotuma are in a similar state of dilapidation. Rehabilitation of the 20-year-old tanks is an option, but the better solution would be to replace them. Plastic or polyethylene tanks are known for their relatively low cost and long life expectancy, and are commercially available in a variety of sizes. In the meantime, rusting roofs and screens keeping out pests need to be replaced.

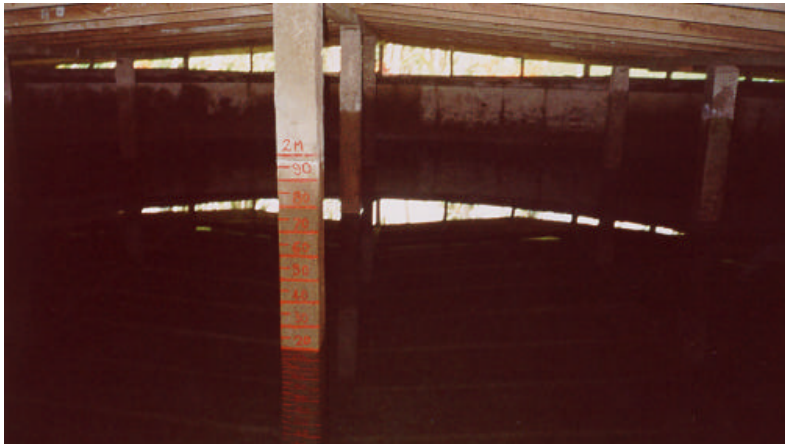
**Picture 8:** Inside the Motusa tank. The water level is indicated from the red markings on the support. The maximum water level is 2 m. The slight elevation of the roof is apparent.

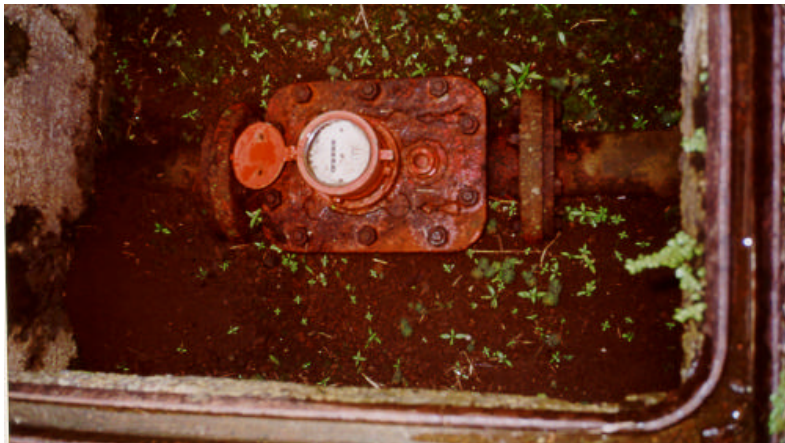
**Picture 9:** The bulk flow meter coming from the Ahau/Matusa tank. Readings are taken every day to give an idea of user consumption.

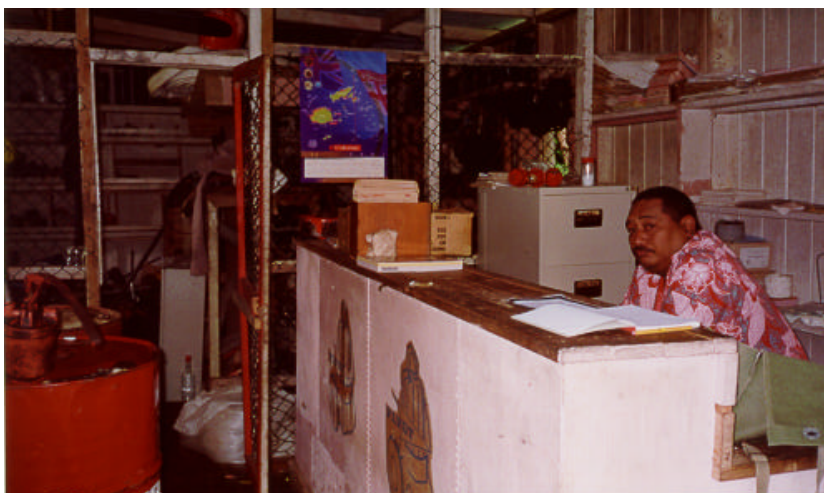
The Rotuma water-distribution system is the responsibility of the Central Division of the Public Works Department water-supply section. The current manager in Rotuma is Henri Vafoou, who has been in the position for the past 10 years. Eight people work for the Rotuma water-supply office, including the three site Wardens, an electrician and a mechanic. The main office in Rotuma is at the government station at Ahau. It is a shack-like building that doubles as an office and a storage warehouse. It is in poor condition and the roof leaks.

**Picture 10:** Henri Vafoou in the water supply office in Rotuma at the government station in Ahau. Meter records are kept here. The roof leaks.

- It is recommended that funds be sought to fix or build a new headquarters for the Rotuma Water Supply in Ahau. The leaking roof could potentially damage hardcopy records and electronic equipment.
