ENGINEERING REPORT FOR PAIES WATER SUPPLY SYSTEM
KITTIMUNICIPALITY, SECTION I, POHNPEI
FEDERATED STATES OF MICRONESIA

May 1996

SOPAC Technical Report 230

Prepared for the FSM/UN Water Resources Assessment and Development
Project by the SOPAC Pacific Water and Sanitation Project funded by UNDP

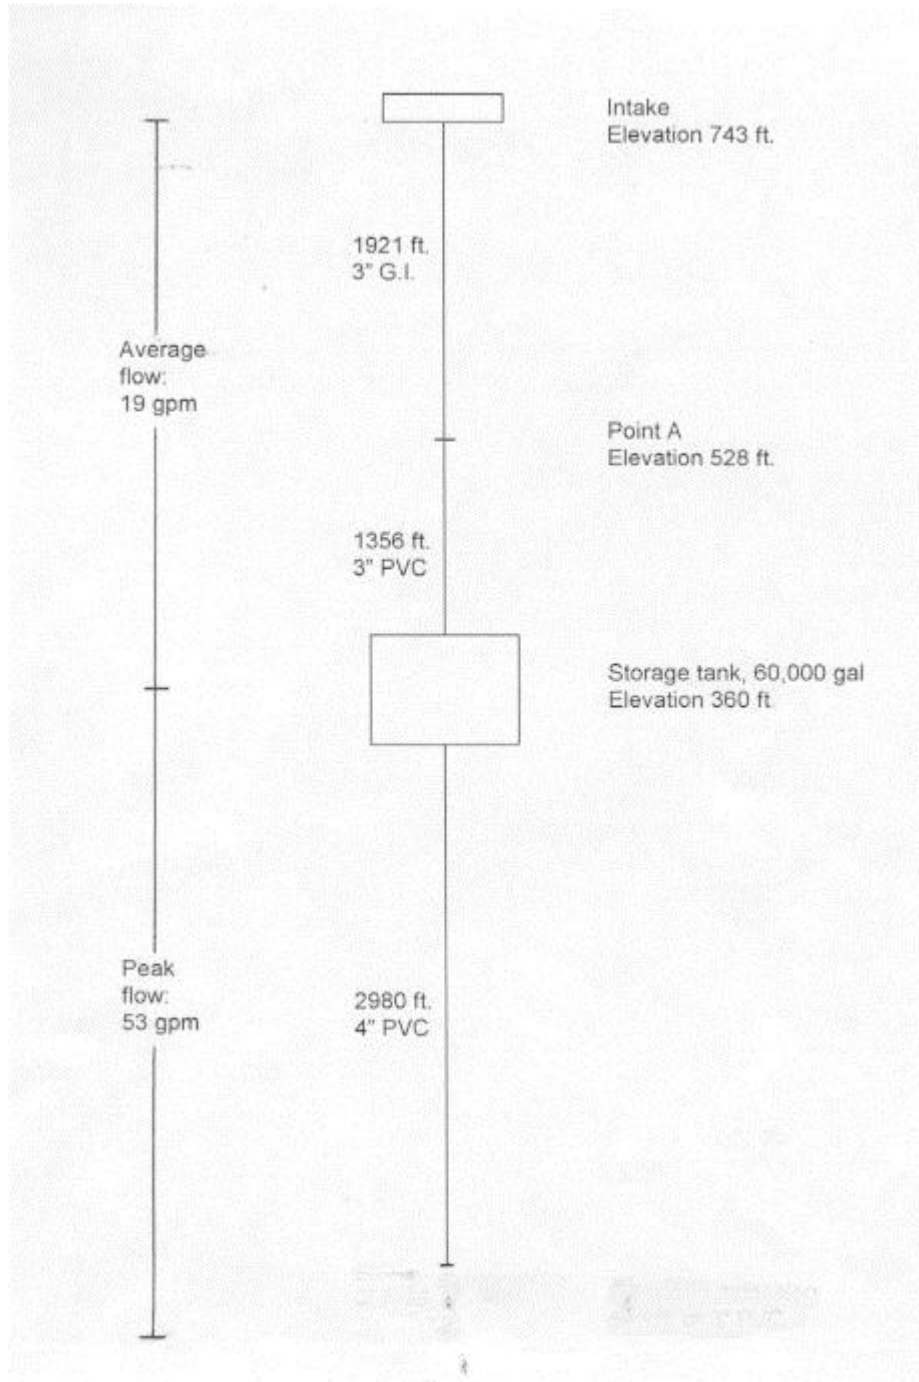
Figure 2. Schematic layout of the Paies water supply system – present situation

The distribution system consists of 2,980 ft (908 m) of 4" diameter (100 mm) PVC pipes. The layout of the system is as shown in Figure 2. At present 9 houses are hooked up to the distribution system. All pipes are buried, with river crossings using GI pipes. As there was no water in the system at the time it was not possible to determine whether there were any leaks in the system.

The hydraulic analysis of the transmission line indicates that the pressure in the pipes becomes too high (Table 1 and Figure 2). The static pressure in the transmission line just before the storage tank is 166 psi (383 ft). This pressure is too high as the pipes are pressure class 150 psi (347 ft). This would account for the large number of breaks that have been occurring on the transmission line. To solve this problem there are several options available:

1. Replace the 3" diameter (80 mm) PVC pipeline with 3" diameter (80 mm) GI pipes which are of a higher pressure class. This would consist of the installation of approximately 1,356 ft (414 m) of 3" diameter (80 mm) GI. The estimated cost is US\$ 10,000.

2. Install a pressure release valve. This would reduce the pressure in the PVC pipeline to an acceptable level. However, as pressure release valves tend to need more maintenance and repairs this would not be the most appropriate solution. Estimated cost US\$ 4,000.

3. Construct a break pressure tank. This would consist of the construction of a 1,000 gallon (4 cubic metres) capacity tank at elevation 528 ft (161 m) above mean sea level, approximately 1,921 ft (586 m) from the intake. This would reduce the pressure in the PVC pipeline to an acceptable level. However, if at a later date a slow sand filter was to be constructed, for the purpose of improving the water quality the break pressure tank would be made redundant. The estimated cost is US\$ 4,000.

4. Construct a slow sand filter. This would consist of the construction of a slow sand filter at tank at an elevation of 528 ft (161 m) above mean sea level, approximately 1,921 ft (586 m) from the intake. The construction of a slow sand filter would not only reduce the pressure in the pipelines to an acceptable level, it would also improve the water quality. Estimated cost US\$ 25,000.

Based on the above mentioned options, the most appropriate option to deal with the high pressures would be to replace the 3" diameter (80 mm) PVC pipes with 3" diameter (80 mm) GI pipes. However, as it is assumed that a slow sand filter would need to be constructed to improve the water quality, it would not be cost efficient to replace the pipelines as well. Based on these considerations it is evident that the construction of a slow sand filter would be the most appropriate long term solution.
