PIPE DETECTION SURVEYS AND CREATION OF A WATER UTILITY GIS, NIUE

Paula Dawe
SOPAC Secretariat

September 2000

SOPAC Technical Report 311

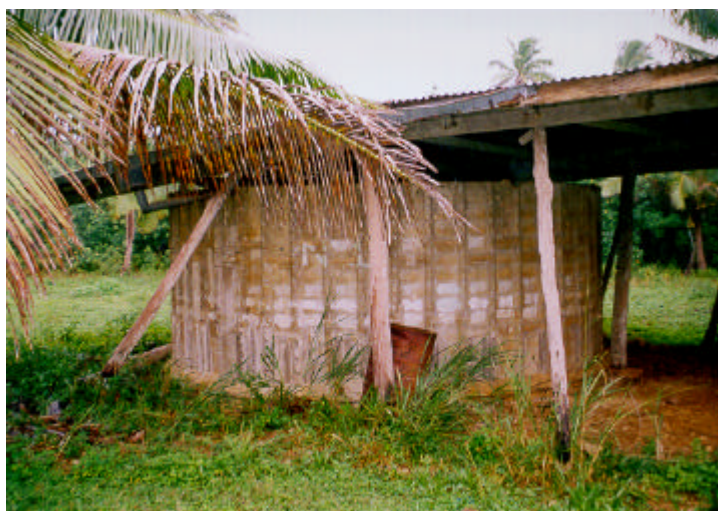
Figure 1: Old rainwater catchment tank

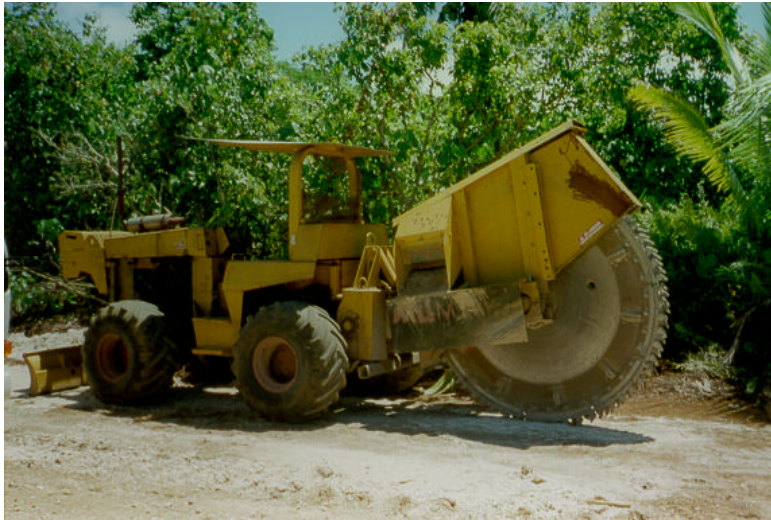
Figure 2: Trench digger used in the laying of pipes and electrical and telephone cables in Niue.

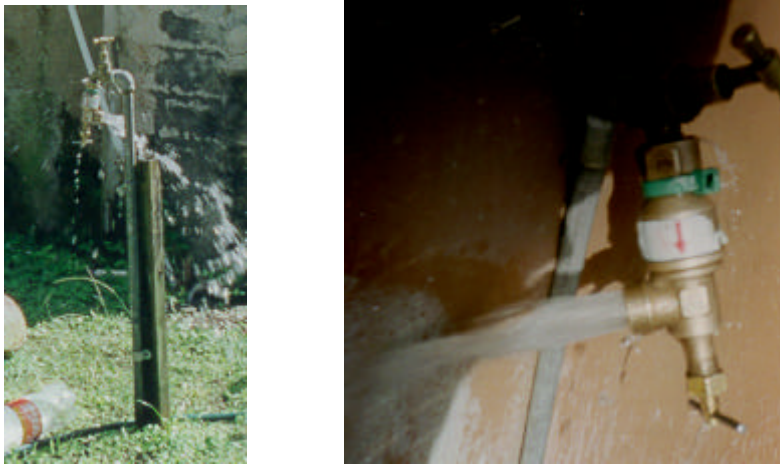
The function of the pipe detector required attachment of a pulse generator (TransOnde) to a 150 mm standard tap nozzle. Once the tap is turned on, an induced vibration could then be heard underground down the length of the pipe, in some cases up to 50 m from the source. Following the length of the pipe, selected spots of interest were then excavated to see what lay beneath. For example, spots where the pulse would change direction usually revealed an elbow, spots where the pulse would branch in more than one direction generally revealed tees. Once the location of the junctions and house connections were determined, a position was taken using the GPS rover.

Figure 3: RD-500 TransOnde

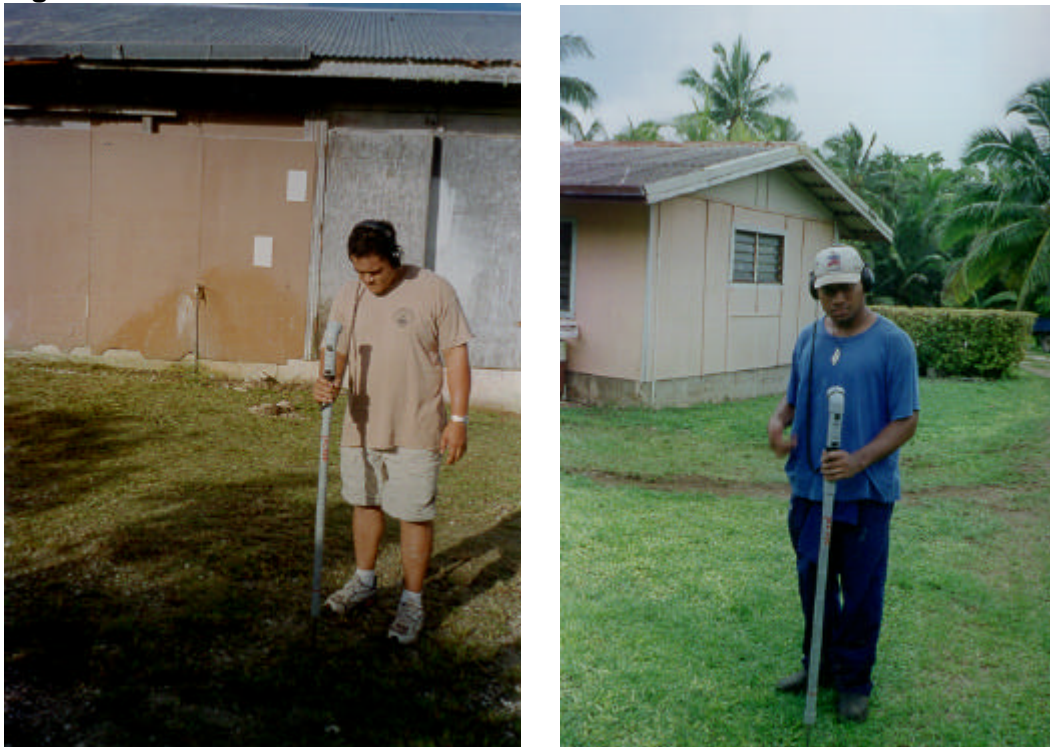
Figure 4: Listening for the generated pulse using the RD-500 PVC pipe detector receiver

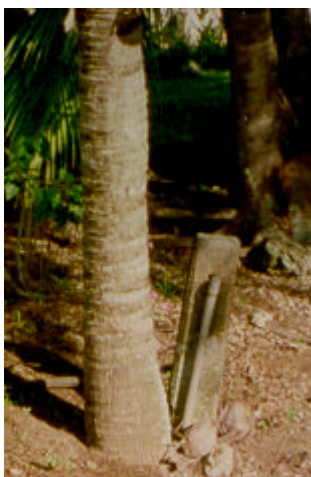
Figure 6: An old village communal tap

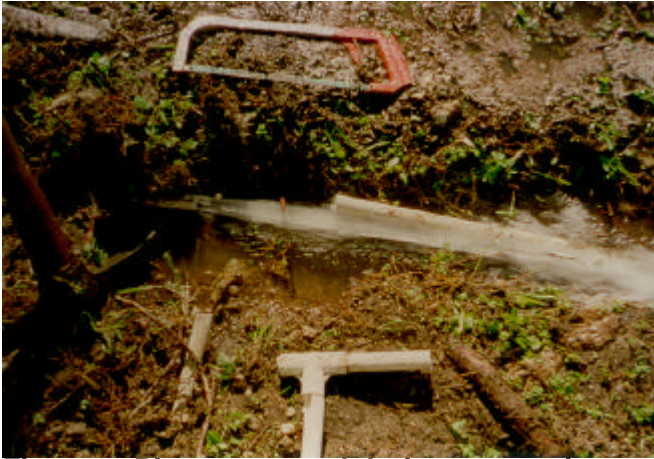
Twice during excavating, a pipe was punctured. This meant a loss of an hour or so to the survey. Furthermore, the work was performed during the hot season, and the energy levels of everyone involved started to flag towards the end of the two-week blitz. However, there were several factors that made pipe detection in Niue quite easy. By law, Public Works has the right to enter anyone's property, and locals were very accepting of having people going over their land, making their pipes bang (in some instances), and digging up patches of their lawn. The fact that water is free in Niue was also very convenient. The pulse generator requires the tap to be turned on full blast. Having meters on each service line would have meant either unfairly charging users for the water used, or having to remove the meters.

Figure 7: Pipe punctured during excavation

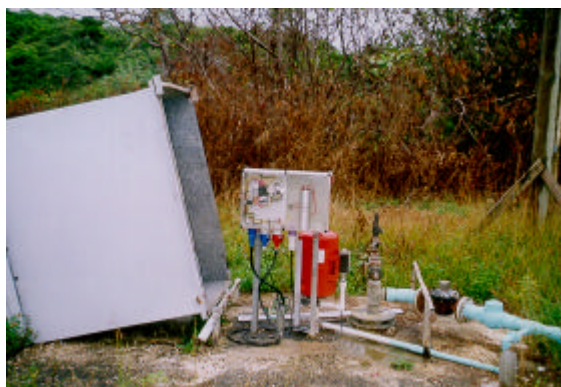
Figure 8: Liku borehole, pump, switchboard, and bulk flow meter

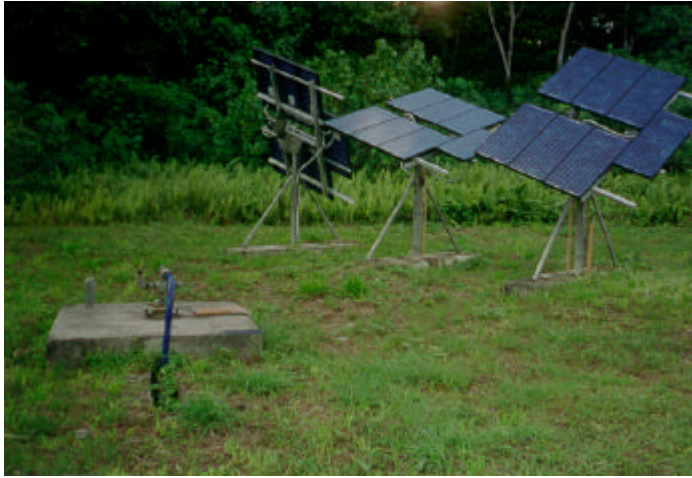
Water is drawn from the boreholes using pumps. All of these pumps are connected to the Niue electrical grid except for the Makefu pump, which is solar powered. The lifespan of these underground submersible bore pumps is between 6 and 10 years.

Figure 9: Makefu solar powered bore hole pump

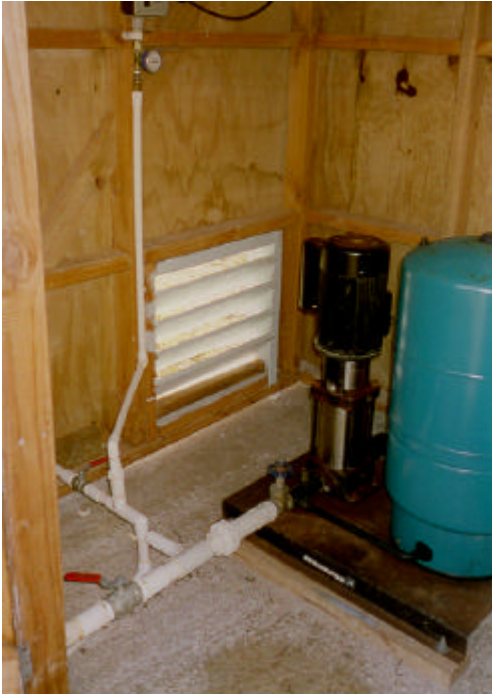
The pressure pumps are controlled by pressure cylinders that maintain system pressures of between 15 and 30 psi in the distribution network. The bore pumps are controlled either manually in the case of the Alofi boreholes, or by permit valves or float controls in the case of the Toi and Vaiea tanks, that monitor the water levels in the tanks.

Figure 10: Pressure pump maintaining 15-30 psi pressure range in village distribution system

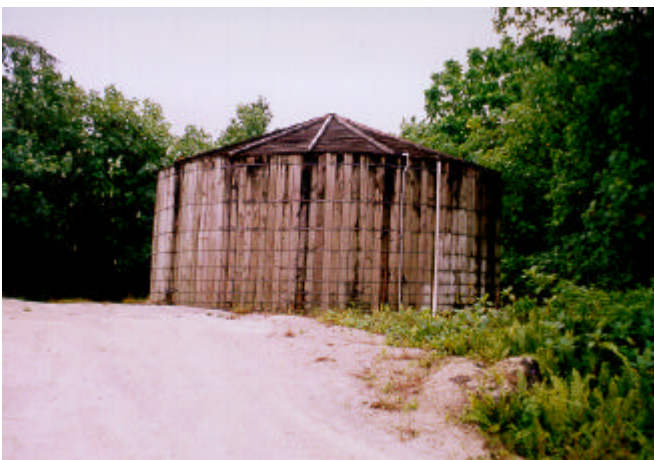
Of the tanks currently in use, the majority are plastic, although Avetele has two timber tanks (only one is in use). The pressure pumps are all located next to the tanks for the seven villages that are not gravity fed. These function to maintain an appropriate pressure in the distribution system between 15 and 30 psi.

Figure 11: Timber tank in Avetele

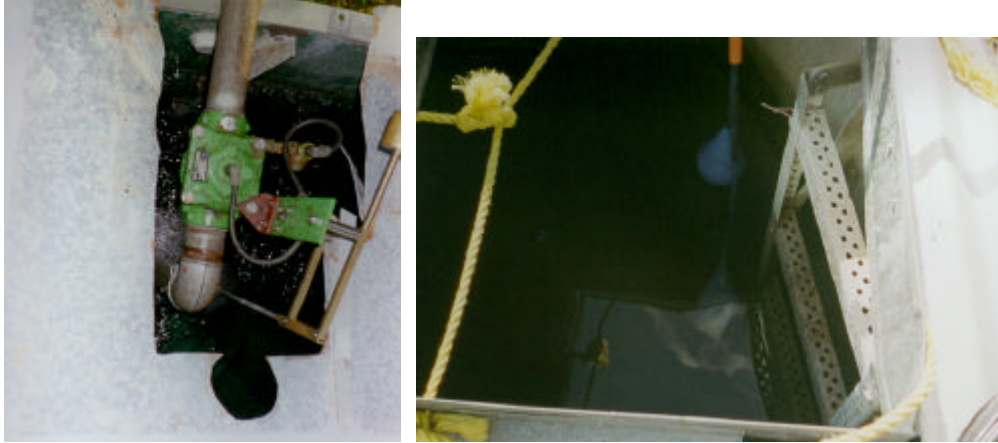
Of all the active tanks, only in the Alofi South and Alofi North tanks are the water levels still manually controlled. Float switches control Toi and Vaiea, and the rest are equipped with permit valves that regulate the activity of the borehole pumps. In this way, the water levels in the tanks are strictly controlled so that no overflowing occurs. However, if not monitored closely, the Alofi North and South tanks will overflow. This was observed during the trip.

Figure 12: Float controls regulating bore pump activities for Toi and Vaiea tanks

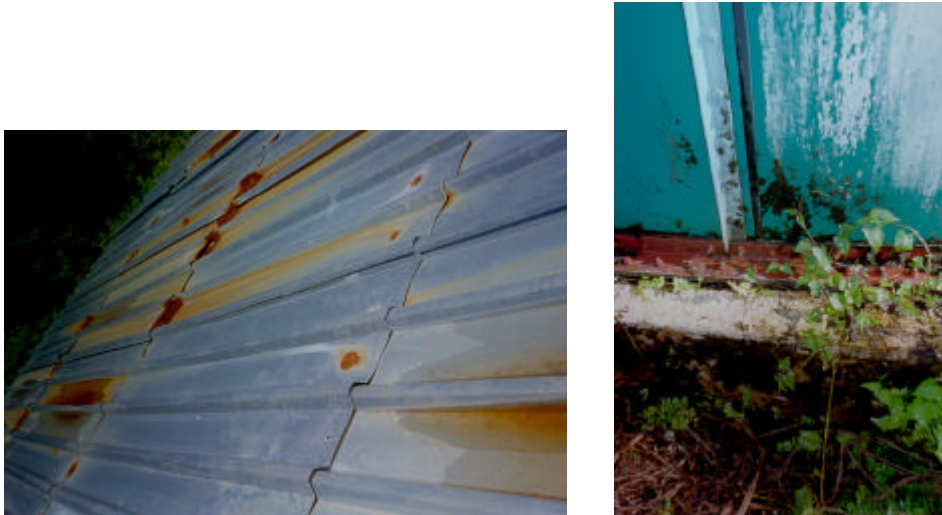
Other problems associated with the tanks include rusting roofs and leaking bases. Six of the tanks have level roofs made of corrugated iron. Rainwater often collects in pools on these roofs and the highly corrosive environment causes them to rust through. The bases of several of the tanks, including the Alofi North and South tanks, also are leaking and will need to be resealed.

Figure 13: Rusty tank roof in Toi and leaking base on Alofi North tank

- That water meters continue to be read on a monthly basis in addition to the electrical consumption meters.
- That maintenance be carried out on the various tanks requiring it. This would include the replacement of flat roofs on the Toi, Lakepa, Liku, Vaiea, and Tamakautoga tanks, and the resealing of bases on Alofi North and Alofi South tanks.

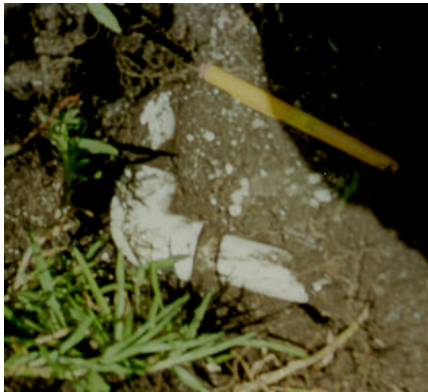
Figure 14: Excavated elbow

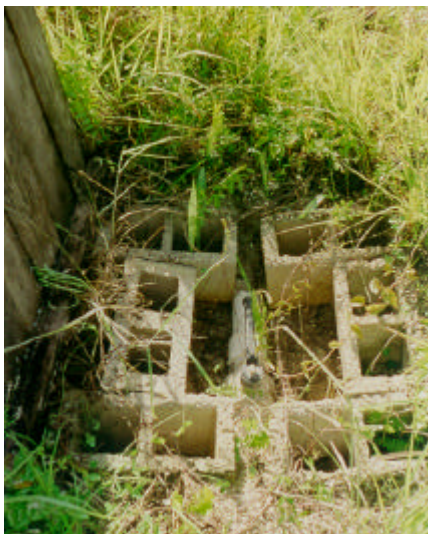
The locating of valves in the Niue distribution system was haphazard. Valves on main distribution lines were generally known and their positions taken. However, valves on household lines were not sought and, unless they were easily identifiable, not taken note of. An excess of valves on the Alofi North network is due to recent upgrades to that system. The main types of valve used in the Niue distribution system are gate valves and pull valves.

Figure 15: Valve along main in Alofi South

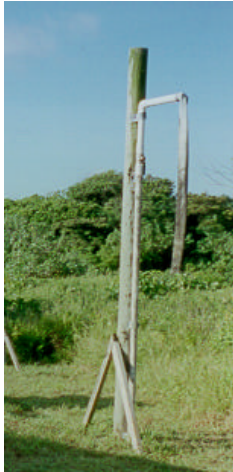
Five fire hydrants were surveyed during the trip. These hydrants consist of tall standpipes with a hose attached at the end, as can be seen in the following picture.

Figure 16: Fire hydrant at Liku borehole

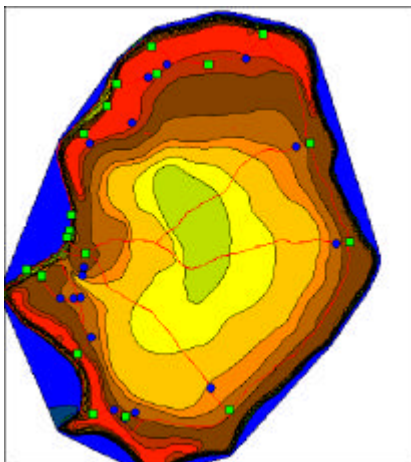
In order to have an elevation associated with the data that were collected, the contour layer was used. The contours in this layer were displayed as regions of elevation at 5-m intervals.

Elevation of points within a region were simply taken to be the average of the upper and lower elevation bounds of that region.

**Figure 18: Contour, road, borehole, and tank layers from the MapInfo GIS of Niue**
