NIUE COASTAL WATER QUALITY AND GROUNDWATER RESOURCES ASSESSMENT

Luke Mosley and Clive Carpenter
SOPAC Secretariat

February 2005

SOPAC Technical Report 372

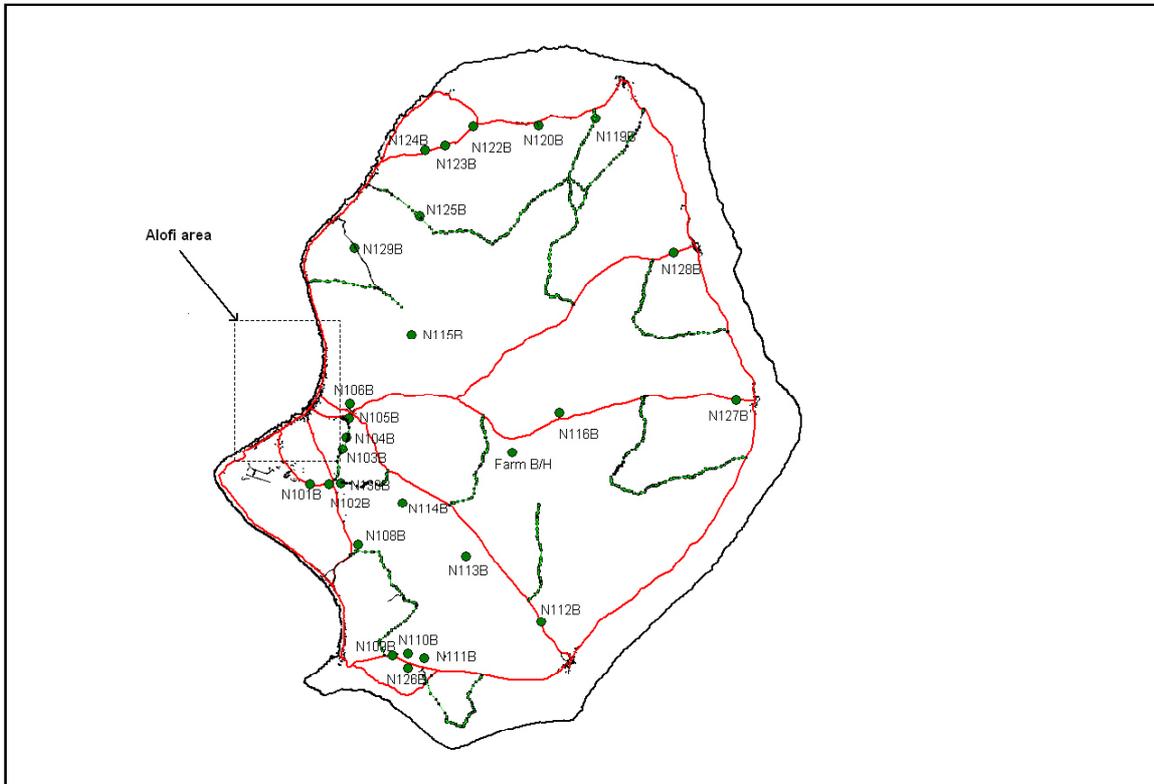
Figure 1. Map of Niue showing borehole locations. The area of the main town Alofi where the majority of the coastal water sampling was undertaken is also shown.

A map of Niue Island and the locations of the groundwater abstraction boreholes is shown in Figure.1

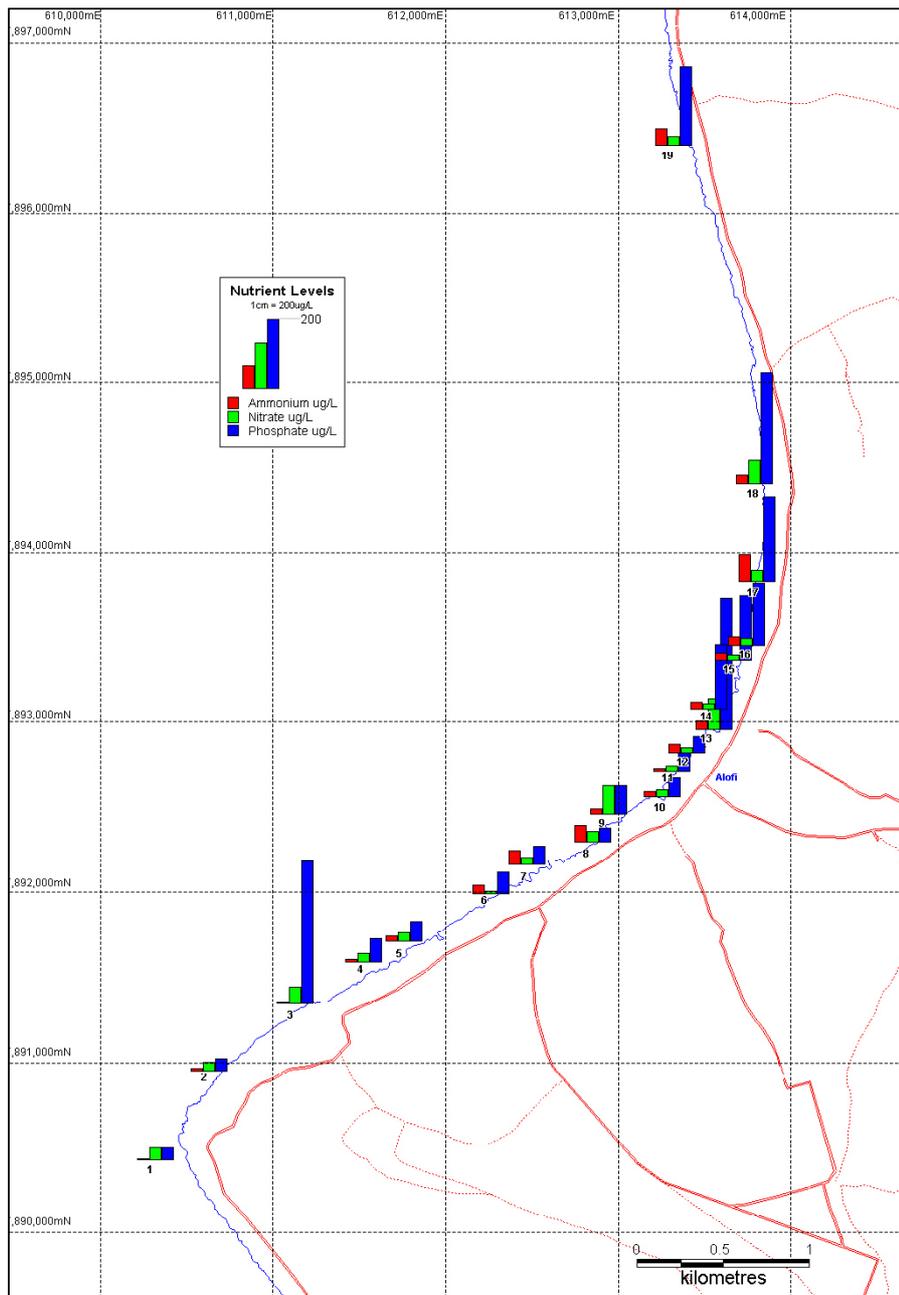
Figure 2: Coastal Water Quality Results for western Niue.

Figure 2 shows the results of the coastal water quality sampling transect conducted in September 2003 (raw data can be found in the Appendix to this report). The coastal water in the Alofi area had nutrient levels (in particular phosphate) that were elevated over background levels (i.e. sites 1 and 2). The sites immediately north of Alofi appeared to show elevated levels compared to the sites to the south. This is likely due to the (prevailing) southeasterly current and wind direction carrying effluent northwards.

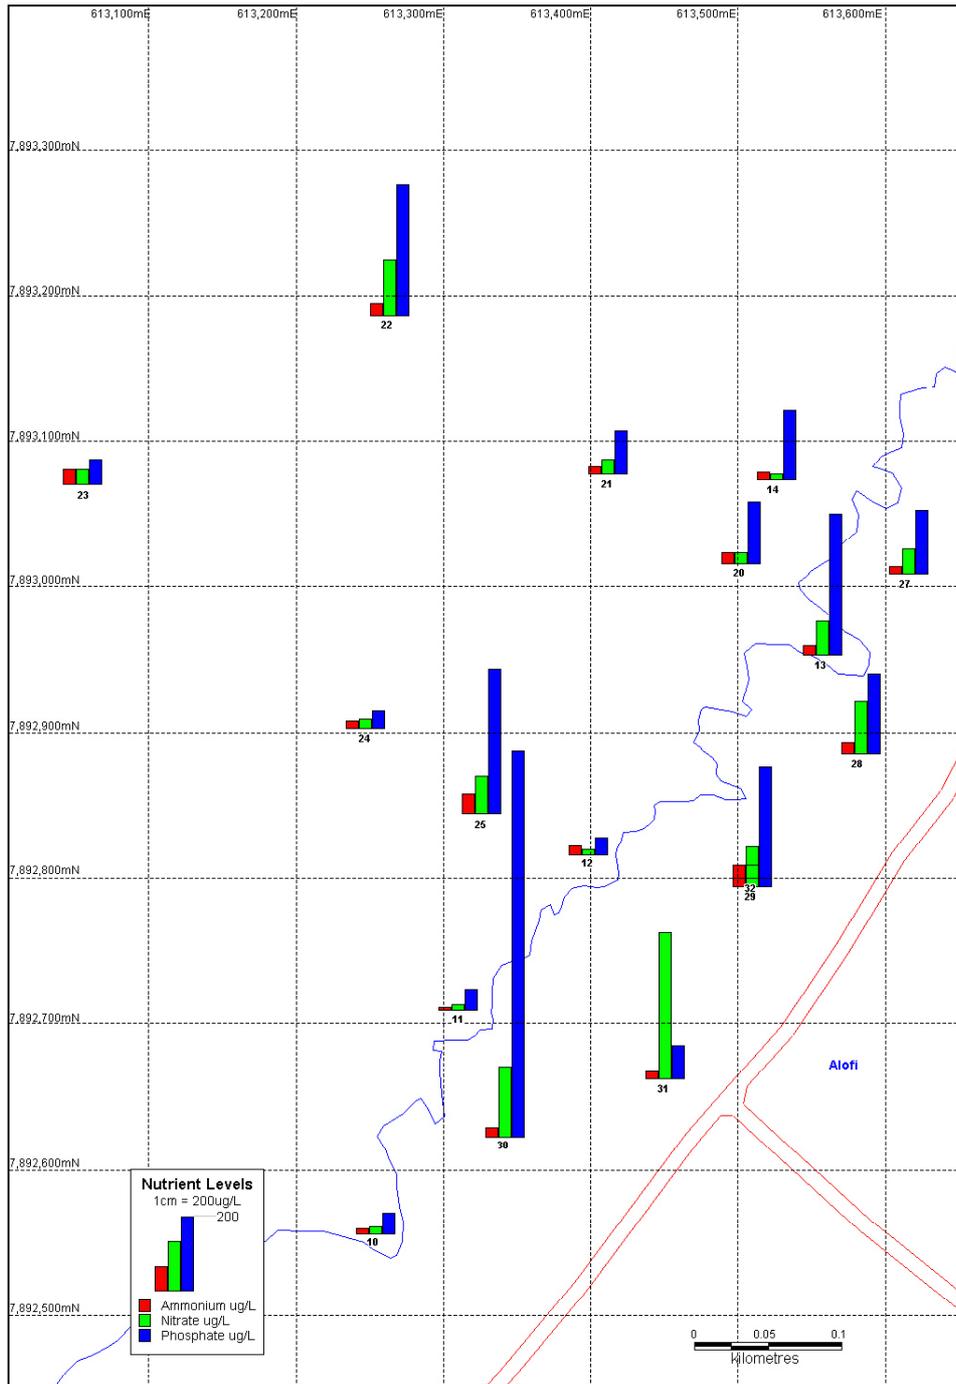
Figure 3: Coastal water quality results around Alofi.

Figure 3 shows the results of the coastal water quality monitoring conducted in the Alofi area in more detail with additional sites on the shoreline (sites 27-32) and two transects outwards perpendicular from the shoreline (Transect 1 sites 13, 20-22; transect 2 sites 12, 23-25) shown. Nutrient levels in the shoreline samples are generally elevated compared to the coastal water, which indicates land-based sources of pollution. The site 22 sample appears to be an anomaly to this general trend. The nitrogen to phosphorus (N:P) ratio found in the samples (see Appendix) was generally low compared to that normally found in open ocean seawater (N:P ca. 14). This suggested that the coastal waters of Niue are nitrate limited but as the sampling in the current study was conducted on only one occasion further sampling is required to confirm these results.

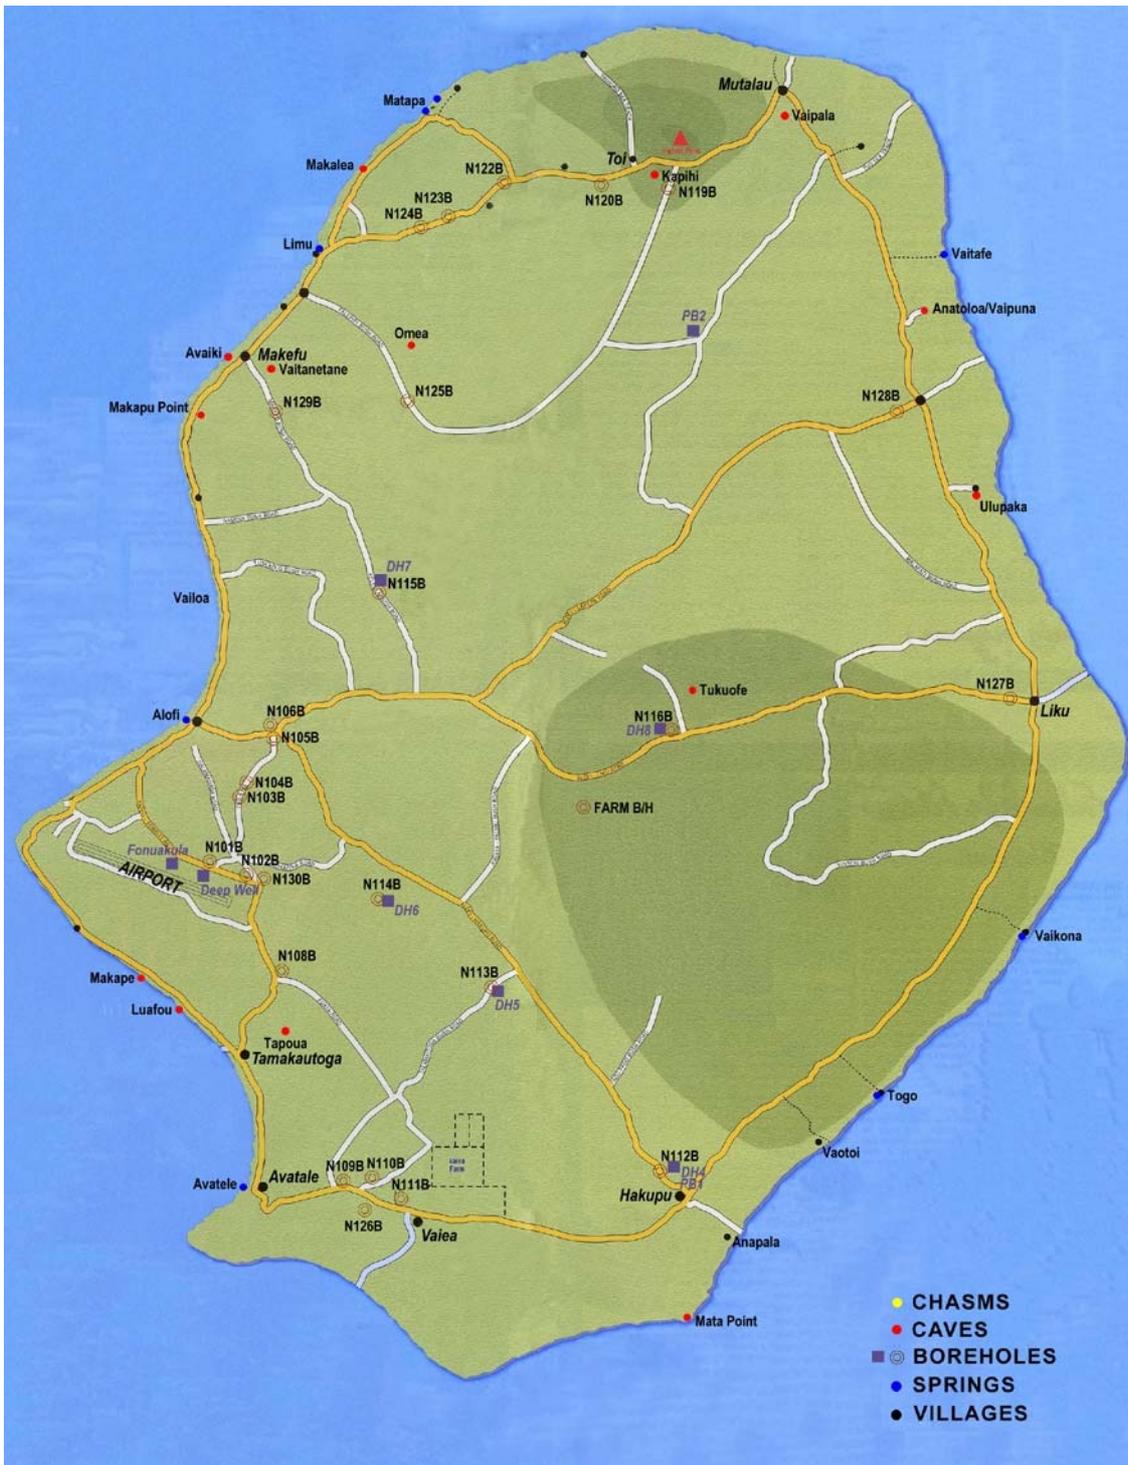
Figure 4. Location of groundwater sample sites.

Sampling and analysis results show that the freshest groundwater is found in the centre of the island and also in a coastal chasm spring. Slightly higher salinities are located towards the coast and near the more heavily abstracted aquifer areas around Alofi.
