# **REVIEW OF THE ROTUMA WATER SUPPLY AND DISTRIBUTION SYSTEM FIJI ISLANDS**

Paula Dawe  
*SOPAC Water Resources Unit*

*February 2001*

*SOPAC Preliminary Report 131*

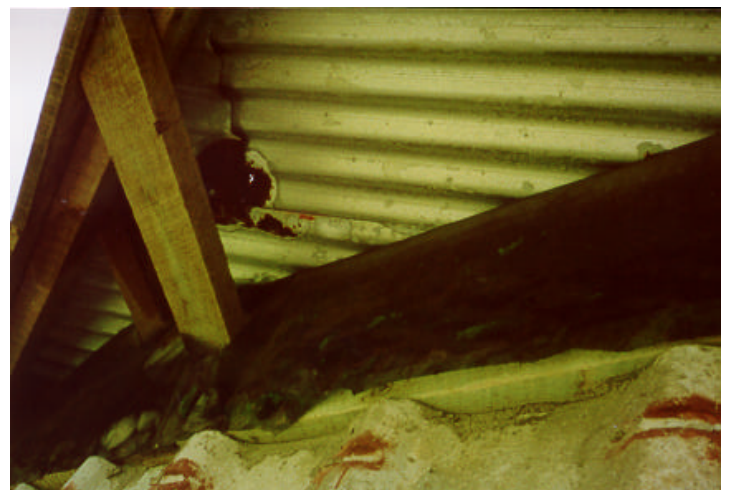
The tank in Lepjea is a circular reinforced-concrete 40 000-gallon (181.84 m<sup>3</sup>) tank. A corrugated iron roof with obvious rust spots covers the tank. The gap between the roof and the tank wall is covered by mesh that is both torn and dirty.

**Picture 7:** A rust hole through the roof of the Lepjea tank. The black mesh to keep pests out of the tank is dirty, torn and sagging between its supports.

- All three storage tanks in Rotuma are in a similar state of dilapidation. Rehabilitation of the 20-year-old tanks is an option, but the better solution would be to replace them. Plastic or polyethylene tanks are known for their relatively low cost and long life expectancy, and are commercially available in a variety of sizes. In the meantime, rusting roofs and screens keeping out pests need to be replaced.
