WATER SAFETY PLAN
For
RAROTONGA

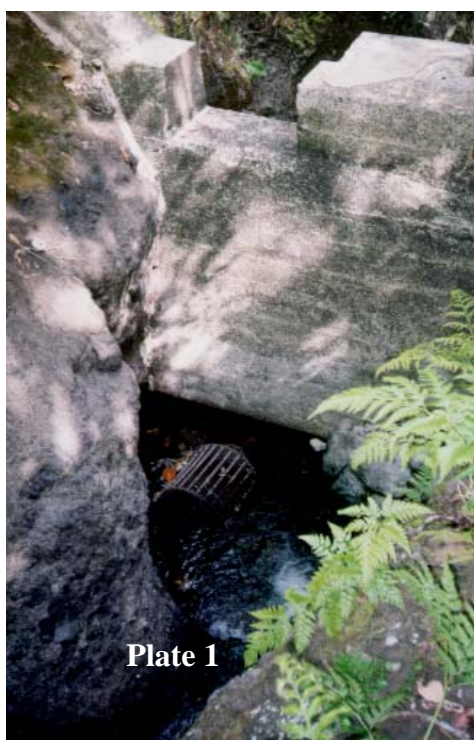
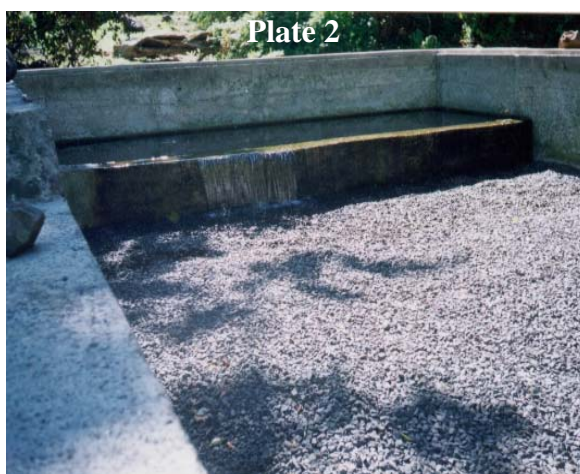
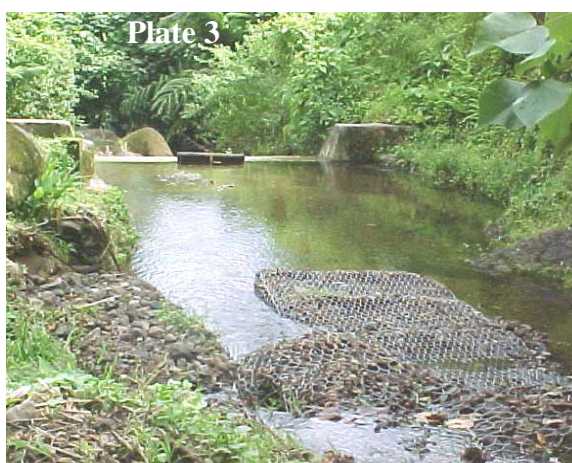
Plate 1: Open Intake

Plate 2: Off-stream rapid filtration

Plate 3: In-stream rapid filtration

Three of the intakes utilize off-stream rapid filtration system; five have in-stream rapid filtration while four have open intakes.

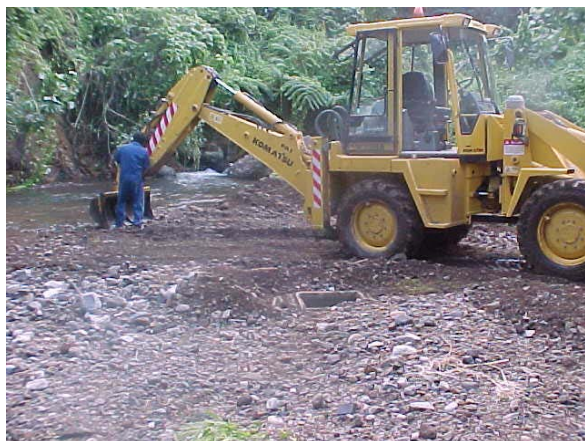
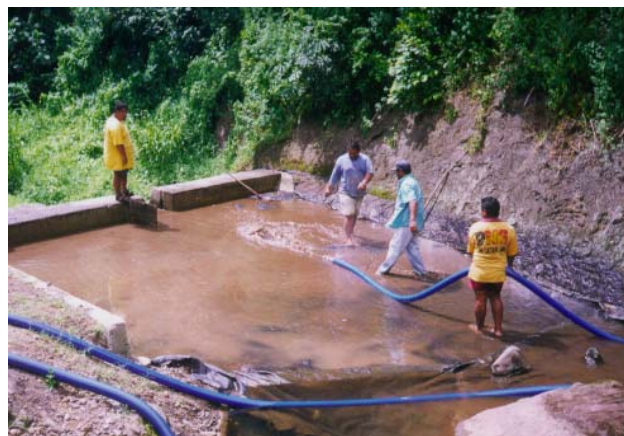
Plate 4: Heavy machinery used to clear 'choked up' intake after flooding

Plate 5: Muddy water at the intake after flooding

Rarotonga is prone to flooding during periods of heavy rainfall. The already shallow streams are severely affected by sediment, rock and debris deposits following the flooding event. DWW have had to engage in clearing up the sediment and rock deposits in order to make the intake operational again.

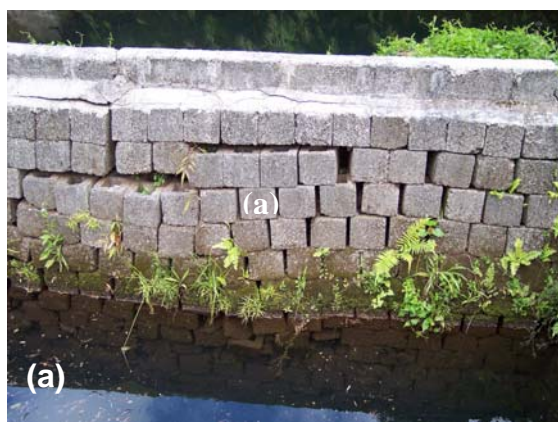
Plate 8: (a) Holding chamber at Avana Intake; (b) Wall conditions of the Holding chamber at Avana Intake

- There is some settling before water passes into the holding tank from the retained pool behind the concrete weir.
- As it moves through the wall structure of the holding tank, large suspended matter is removed
- As the water enters the distribution main, it passes through a coarse wire netting (mesh) which removes any remaining debris and large solids or suspended matter

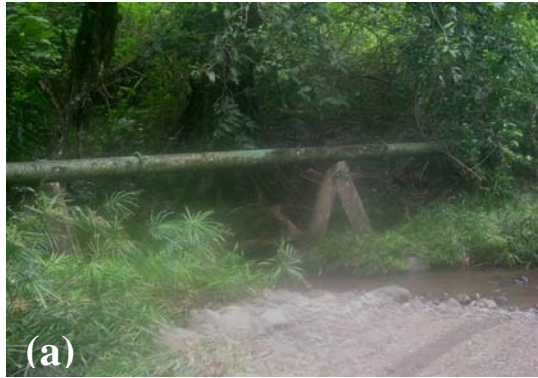
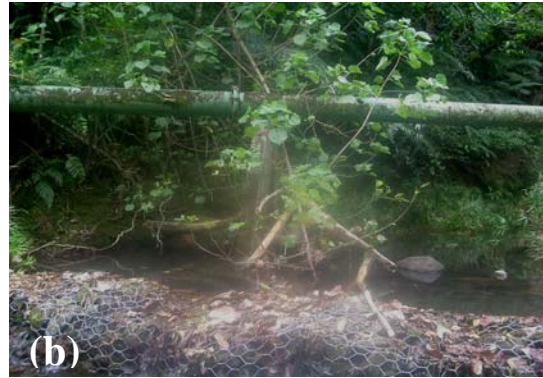
Plate 9: (a) Pipe transporting water from Avana Intake to the distribution main; (b) Stream crossing – gabion basket wall has been constructed to support concrete pillars from being washed away during floods.

- There is no storage within this system.
- The pipe crosses the Avana Stream nineteen times and where it crosses these crossings, the pipe is constructed of a metal alloy. This is joined with a flexible coupling, which has the ability to “pop off “when extreme forces are acting upon it e.g. during a flood. This enables this piece to be reconnected within a short period of time. The bolts, which hold the metal pipe together, are covered with denso tape to prevent corrosion (the tape is replaced once every two years).

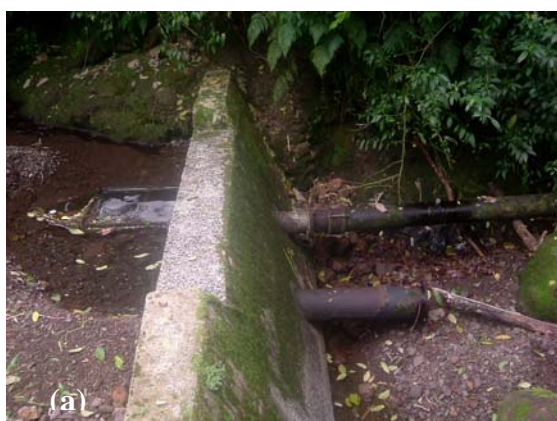
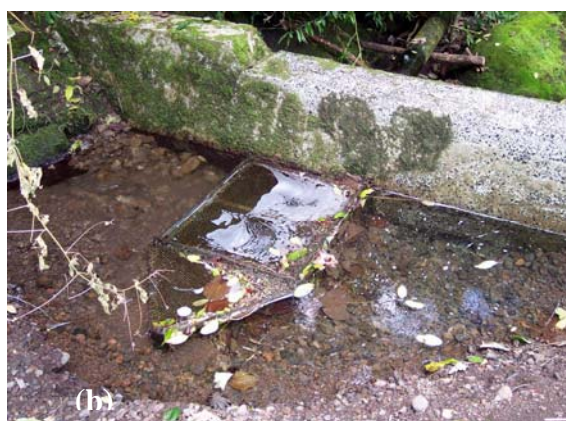
Plate 10: (a) Tupapa Intake; (b) Coarse screen removes large debris

- Located in the Eastern part of the island, the intake for this supply is directly in the streambed. A small dam has been constructed to retain the water. A coarse screen has been placed at the mouth of the intake, which removes most large debris. This intake captures almost 90% of the stream flow.
- Extensive cultivation and farming activities within 100m of the intake
- Open access for people and animals
- Tourist Trekking through the Catchment
- The catchment is again steep bush covered hills.
- The Tupapa Stream is not known to dry up, and in times of flood the entire intake can be covered with debris.
- The intake is checked and cleared 3 times a week.

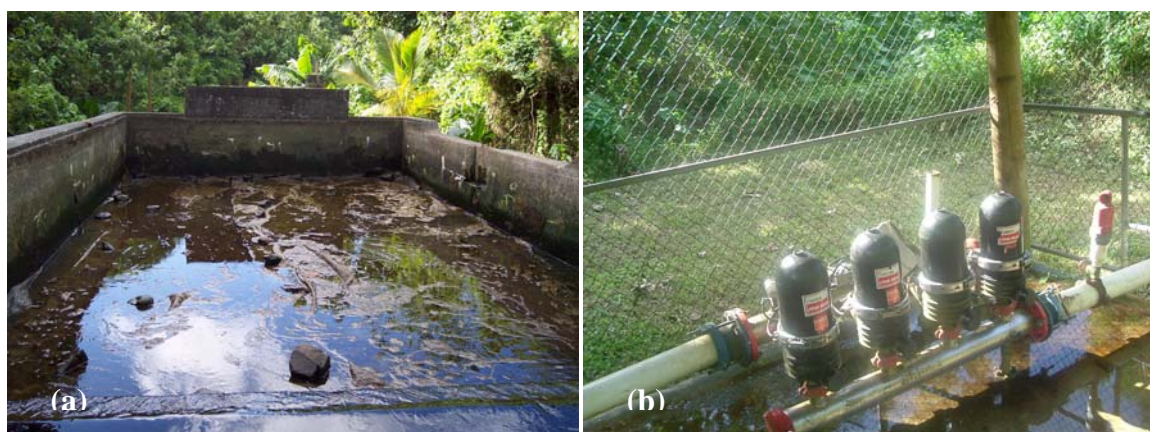
Plate 11: (a) Geo-textile bed at the filtration chamber; (b) Four spine ARKAL filtration system

- Filtration through Geo-textile material
- Water then flows down to a four spine ARKAL ring filters. The filter system does not use external energy and the operation of the filters is based entirely on hydraulics. These filters contain a series of plastic rings, which act as filters (120 microns mesh). The output flow from the filter system is dependant on the down stream demand. The system can be set to self flush but is dependant on the upstream head pressure. An automatic timer can be set for backwash, but currently this is done manually.

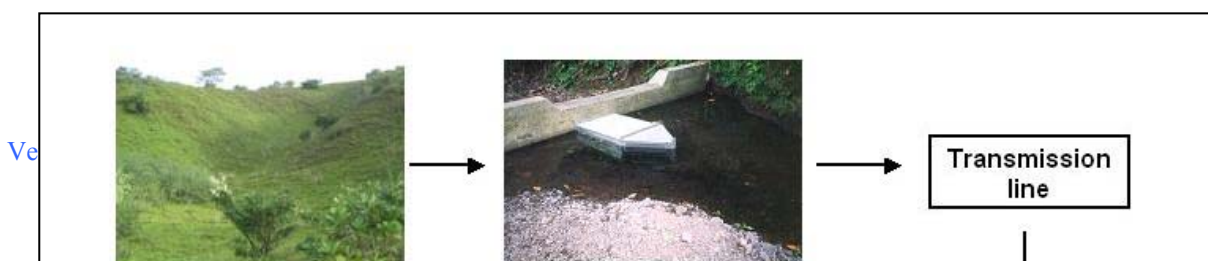
Figure 13: Schematic for Muriavai Intake

- There is screening using metal grates, but no storage

- Water is gravity fed into the distribution network
- Some Households supplement the reticulated supply with Rainwater Catchment
- Some Households also have holding tanks to store reticulated water
