Navua River

1. COUNTRY INTRODUCTION

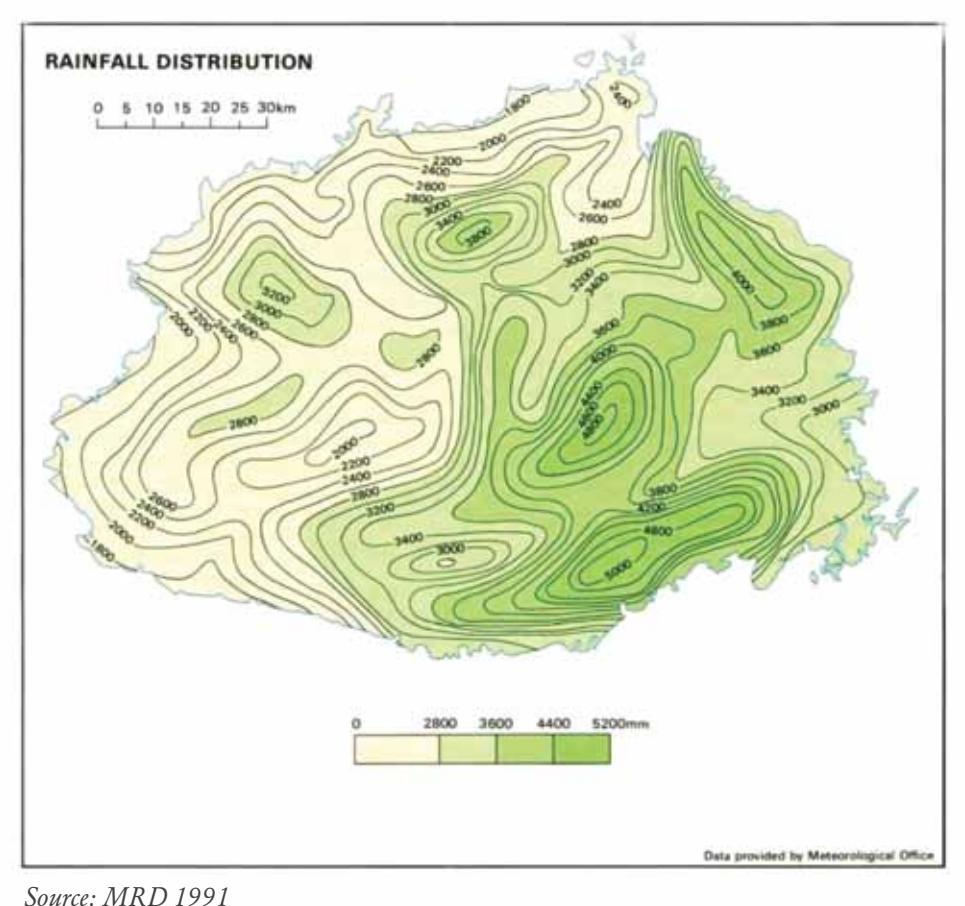
Rainfall distribution on the Island of Viti Levu

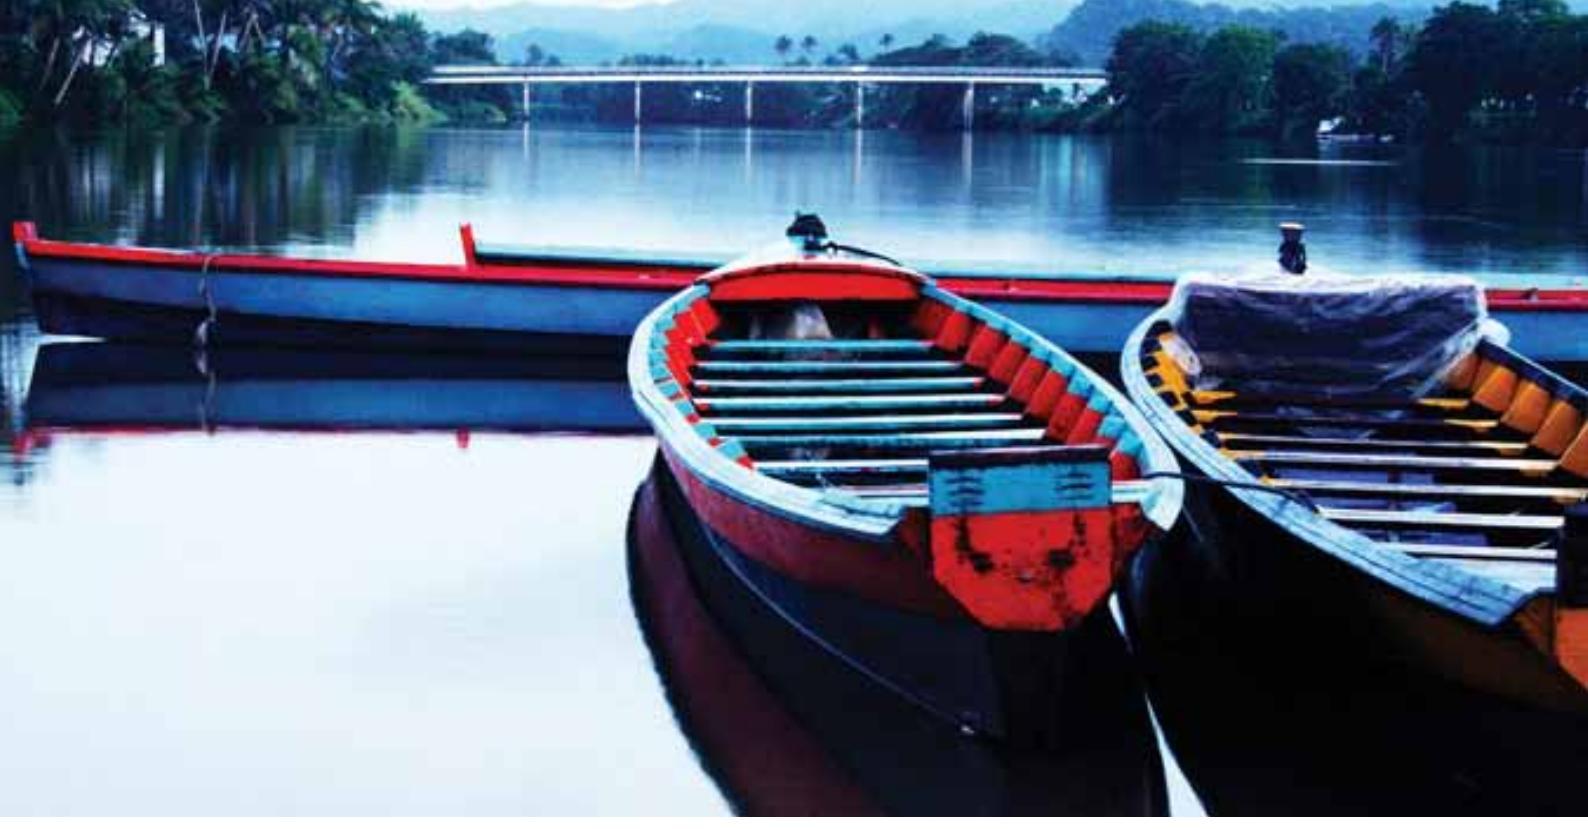
The Navua FWS was installed under European Development Funding (EDF8) in 2007 with SOPAC support. Pacific HYCOS continued to provide support to the NHS with field operations, training and resolving the difficult communication issues. Rating curves have yet to be developed for the Navua and flow data cannot be presented.

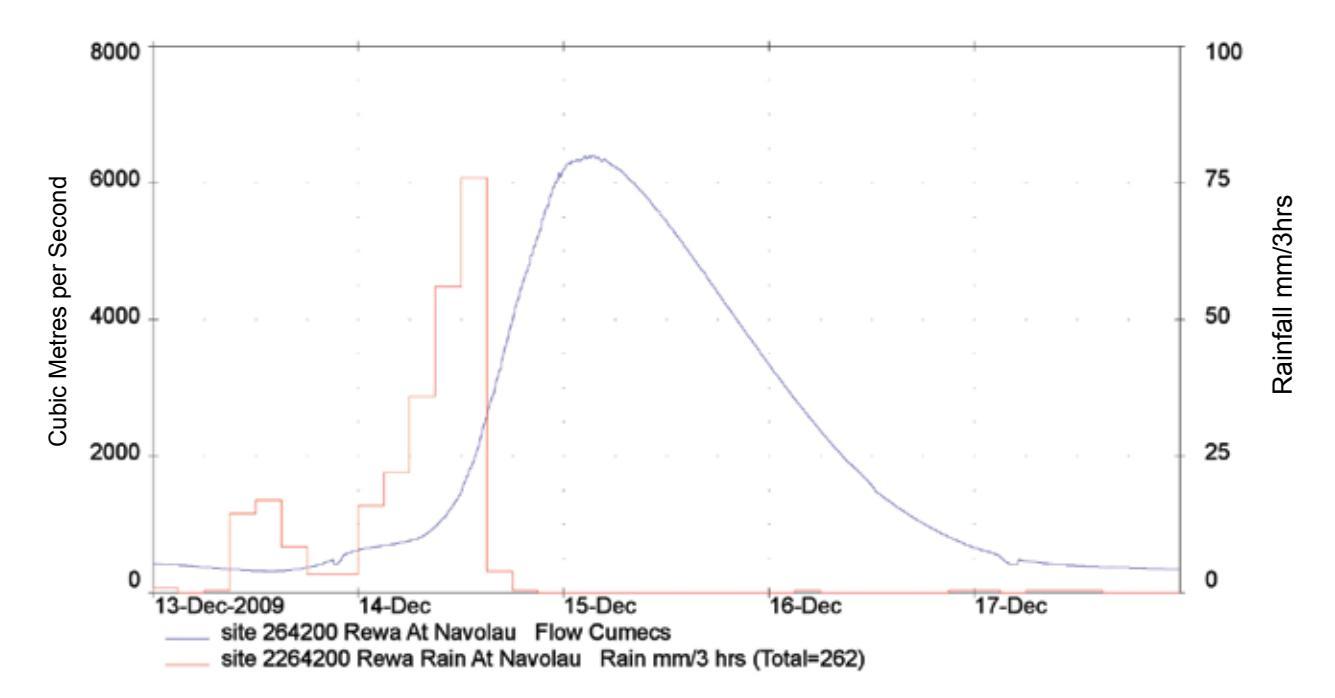
Rewa River at Novolau Discharge and rainfall December 2009 flood.

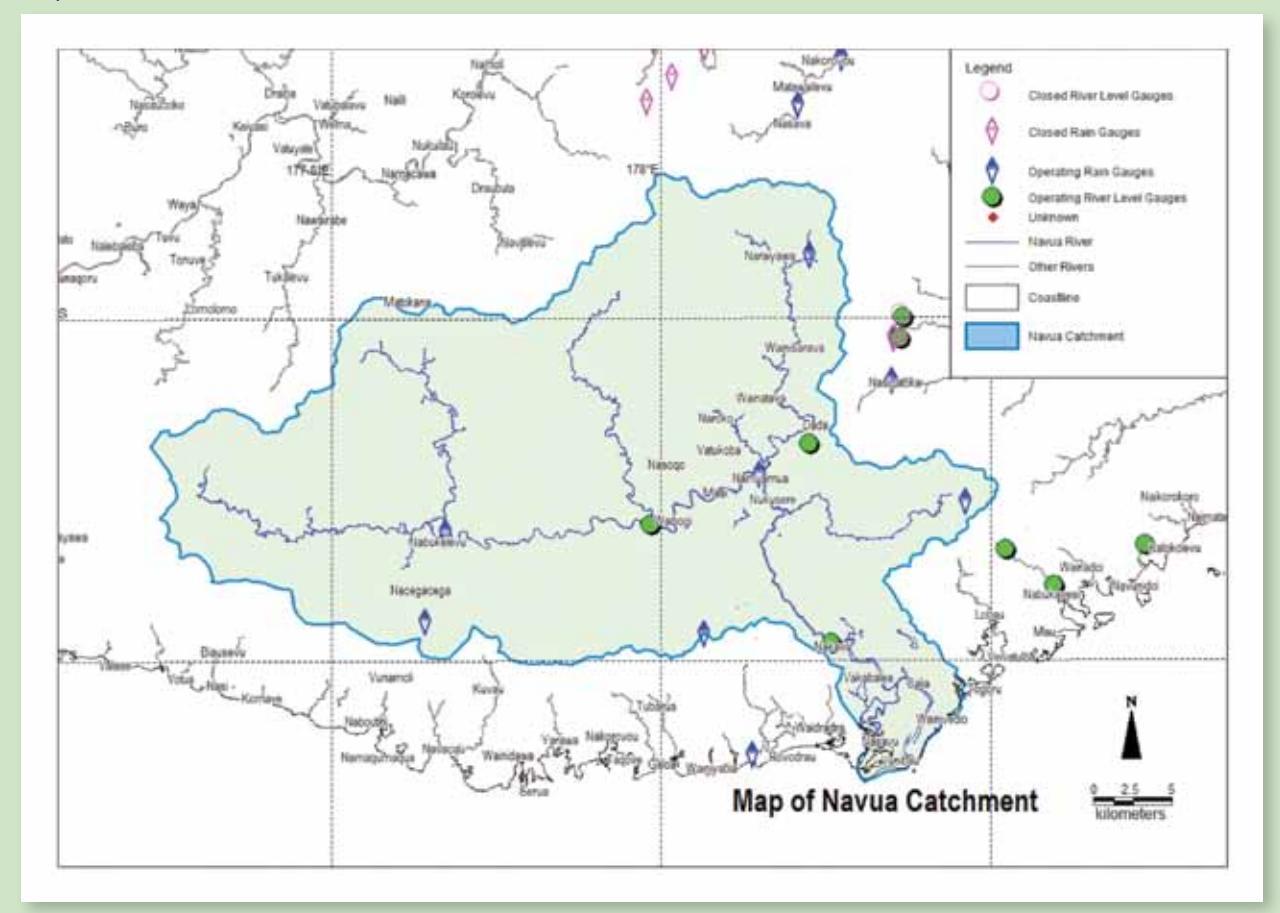
Map of Streamflow and rainfall Observation Stations within the Navua Catchment.

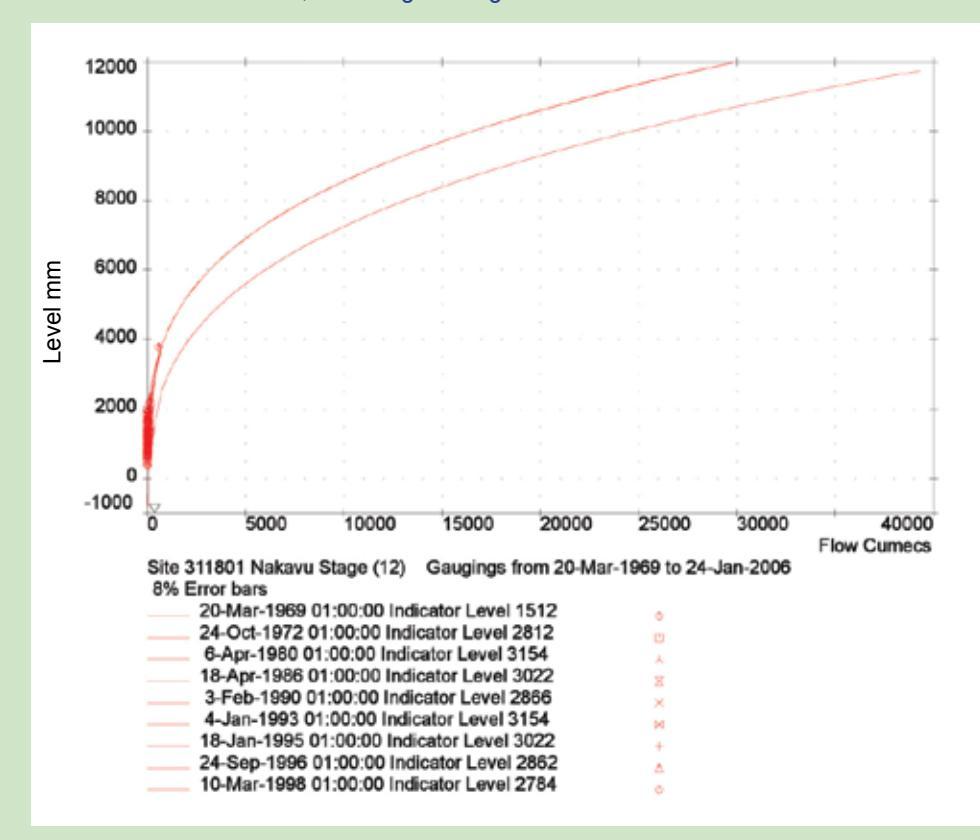
Navua River at Nakavu, discharge rating curve Station No. 311801

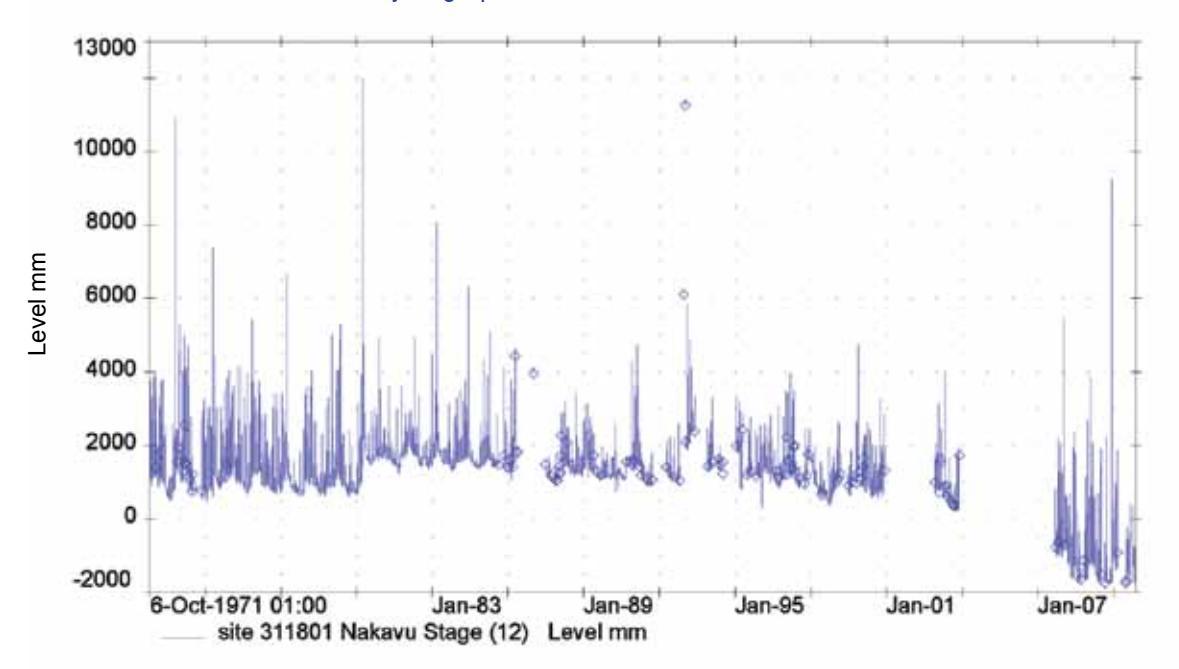
Navua at Nakavu, water level hydrograph Station No. 311801
