## Effects of a Tropical Cyclone on the Drinking-water Quality of a Remote Pacific Island

*The effect of a cyclone (Ami, January 2003) on drinking-water quality on the island of Vanua Levu, Fiji was investigated. Following the cyclone nearly three-quarters of the samples analysed did not conform to World Health Organisation (WHO) guideline values for safe drinking-water in terms of chlorine residual, total and faecal coliforms, and turbidity. Turbidity and total coliform levels significantly increased (up 56 and 62 per cent, respectively) from pre-cyclone levels, which was likely due to the large amounts of silt and debris entering water-supply sources during the cyclone. The utility found it difficult to maintain a reliable supply of treated water in the aftermath of the disaster. Communities were unaware they were drinking-water that had not been adequately treated. Circumstances permitted this cyclone to be used as a case study to assess whether a simple paper-strip water-quality test (the hydrogen sulphide, H<sub>2</sub>S) kit could be distributed and used for community-based monitoring following such a disaster event to better protect public health. The H<sub>2</sub>S test re

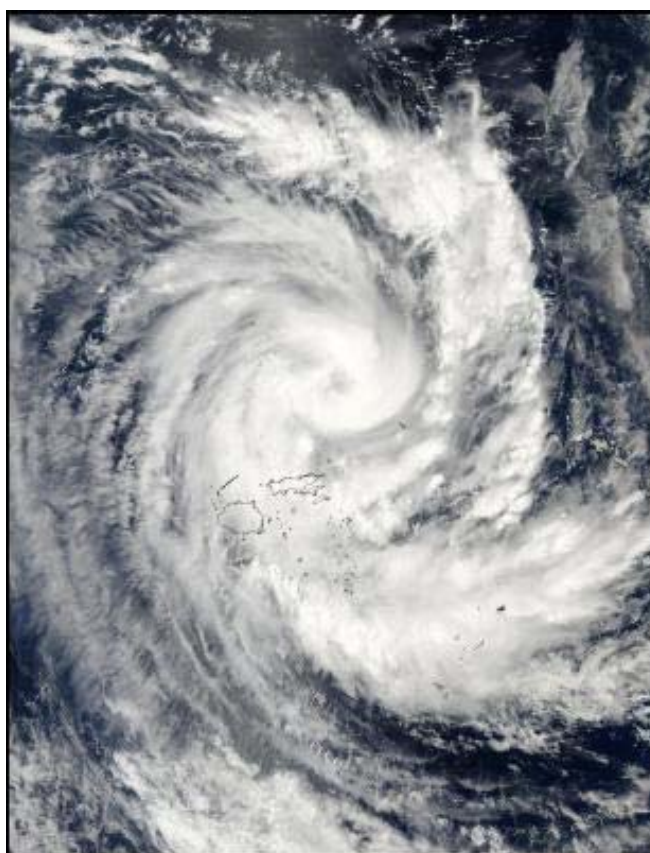
**Figure 1** The location of Vanua Levu in the Fiji Island group and the path and satellite image of Cyclone Ami (Source: Fiji Metereological Service)

The Pacific islands are continually subject to the effects of natural disasters, with an average of eight tropical cyclones per year in the south-west Pacific during the period 1920–94 (Radford et al., 1996). From 12–15 January 2003, Cyclone Ami hit the Fiji Island group (see Figure 1) and had a devastating effect on the islands of Vanua Levu, Taveuni and the eastern islands of the Lau group. Average windspeeds were between 80 and 110 knots and very high rainfall was recorded (300–400 mm/day). In Vanua Levu, at least 14 lives were lost in a large flood that swept through a settlement in the middle of the night. Many homes, bridges, roads and plantations were destroyed. Labasa, the main town on this island was under three metres of water at the peak of the flooding. The supply of piped water in some areas was disrupted due to infrastructure damage and on some supplies, treatment was not maintained. Approximately one month following the cyclone, rumours led to concerns about the quality of drinking-water, particularly on the island of Vanua Levu. Health authorities were concerned that outbreaks of typhoid fever and vector-borne diseases such as dengue fever would occur.

Sampling was undertaken approximately four weeks after Cyclone Ami subsided, when the potential for a disease outbreak was noted by health authorities. Samples were taken from a number of sites around the island of Vanua Levu, in the northern Fiji Island group (see Figure 1). The majority of samples were taken from the publicly owned supplies, although several private boreholes were sampled. For the publicly-owned supplies, samples were taken at both the water sources (river intakes and boreholes) and also at reticulation endpoints. Before samples were taken, all standpipe taps were flamed for approximately 30 seconds to destroy any bacterial contamination present on the mouth of the tap. For the analysis of faecal and total coliforms, a 500ml sample was collected in a sterile glass bottle, stored in ice in a cooler and returned to a basic laboratory in the town of Labasa. The time between sampling and further processing of the samples was less than eight hours.
